# PROPERTY INSPECTION REPORT

CLIENT: Sam Sample

INSPECTOR: Korey Pavlika

DATE OF INSPECTION: 7/22/2025

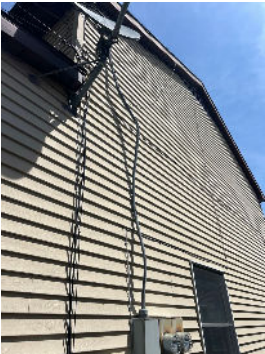
1.2. The electrical service wire is not secured adequately to the exterior of the home. Recommend adding approved fasteners to secure the service entrance wires.

Service entrance wire isn't fully secured to the home

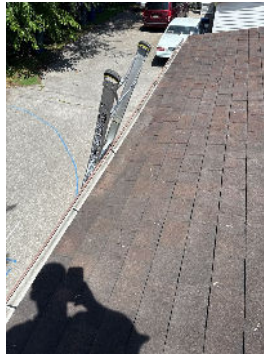
Soft spot observed on the lower northwest corner

1.2. There are areas of granular loss (see pictures) indicating the roof is older. Recommend having a professional roofing contractor assess the roof for repairs/replacement.

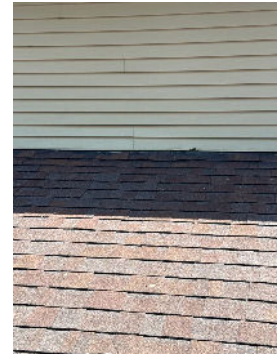
Several nail pops observed alongside the headwall flashing

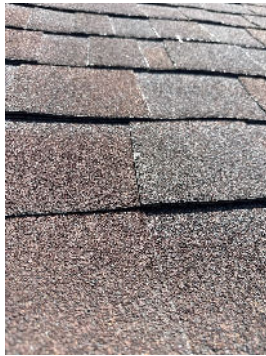
The fiberglass matting is exposed along the edges of the shingles indicating a roof near the end of its life

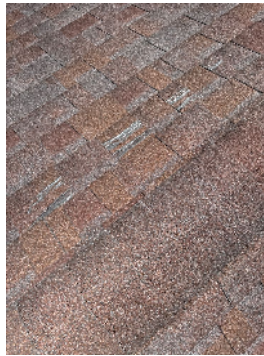
Handful of damaged shingles alongside the upper section of roof

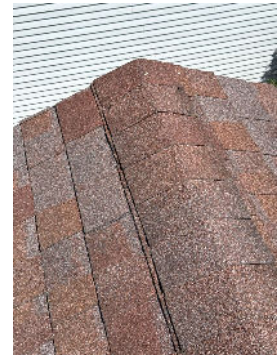
Commonly exposed roofing nails along the end of the ridge cap

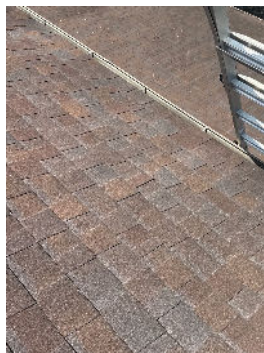
Several other soft spots observed along the eaves of the roof line

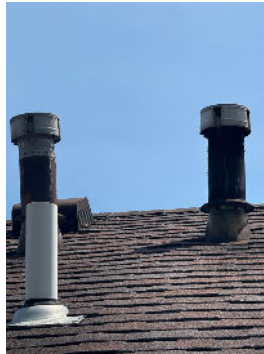
Both vent pipes are heavily corroded and will likely need to be replaced

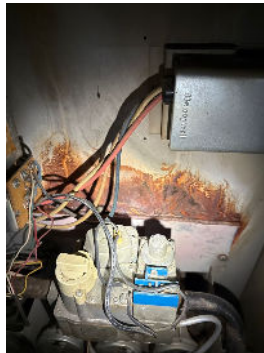
The furnace has exceeded its typical lifespan and is considered to be well beyond the expected service life. The system is likely to be inefficient and may experience frequent breakdowns or failures. Ongoing repairs may become increasingly costly, and energy efficiency will likely be very poor. Replacement is strongly recommended, as the furnace is unlikely to perform reliably for much longer. The inspector does not guarantee future performance and strongly advises consulting with an HVAC professional to evaluate replacement options as soon as possible.

Significant amount of flare ups observed inside the furnace cabinet

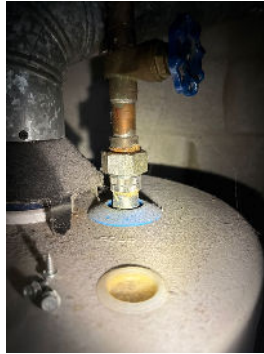
5.1. Corrosion observed around the dielectric(s). This means there has been a leak present at some point in time. Recommend monitoring the corrosion for future leaks.

Small amount of corrosion observed on the dielectrics

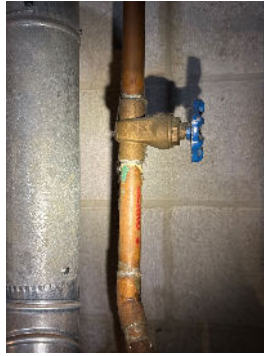
Small amount of corrosion on the supply line fittings

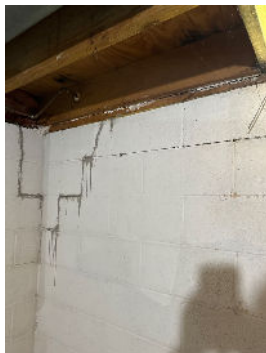
1.3. There is a shift in the block (see picture). This means that the block has shifted away from the remaining blocks of the home. Recommend a professional masonry contractor to assess the severity of the shift for proper repairs.

1.4. Diagonal stair stepping settling crack that is wider along the top and slimmer along the bottom of the crack. This means that the foundation may be settling allowing these types of cracks to show up. These cracks can allow water to intrude into the home and may be expanding and contracting in response to the weather. Recommend a basement professional to assess the severity and provide any solutions/repairs needed.

Stair stepping crack and small shift in the block on the southeast corner

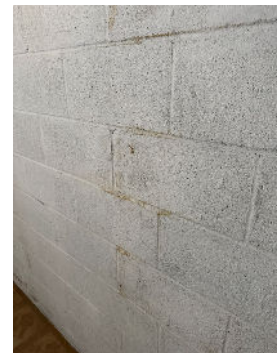
1.1. Efflorescence is the white, powdery substance that can appear on the surface of concrete, brick, stone, or masonry. It forms when water moves through the material, carrying soluble salts with it. As the water reaches the surface, it evaporates, leaving the salts behind in the form of white deposits. While this is considered a cosmetic issue it can indicate ongoing moisture problems that might lead to more serious issues. We recommend addressing any leaks, drainage issues or moisture problems that are allowing water to penetrate the material.

Efflorescence observed along the south wall

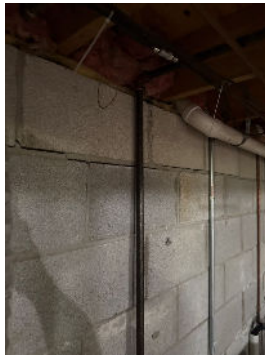
Small horizontal crack along the west wall top course

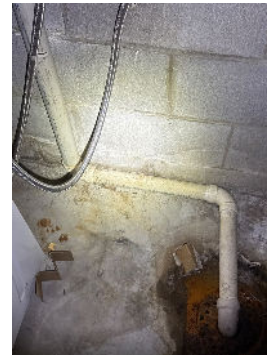
Efflorescence observed along the west wall

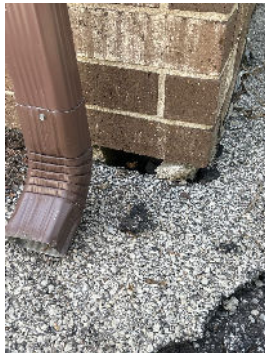
2.3. Missing block(s) observed (see picture). Recommend having a professional masonry contractor assess and install a new block as needed.

Block has deteriorated and is missing on back left corner of home

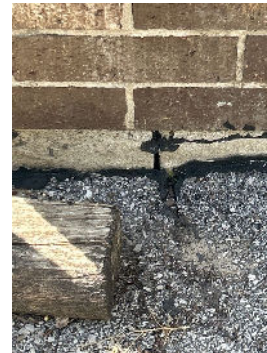
2.2. Minimal amounts of mortar observed in the joints between the block (see picture). These joints should be filled with mortar to ensure a tight seal between the block. Recommend adding additional mortar to these areas.

Deteriorated mortar joint in front right corner

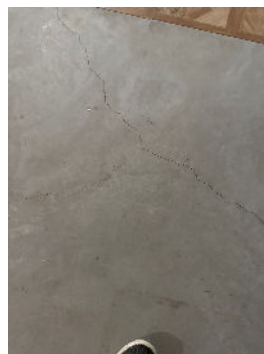
Common cracks noted

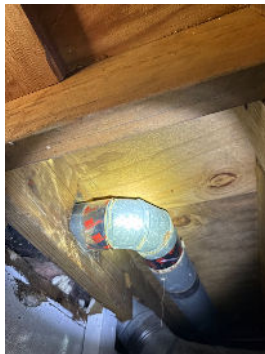
Mold like substance observed along the south side subfloor

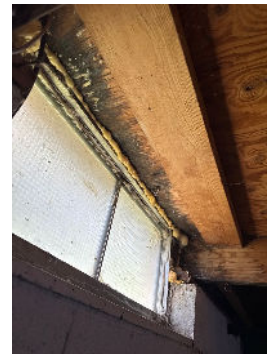
6.1. Rotten sub floor is observed (see picture). Recommend a professional contractor to repair/support the area(s).

Small amount of rotten subfloor on the southeast corner

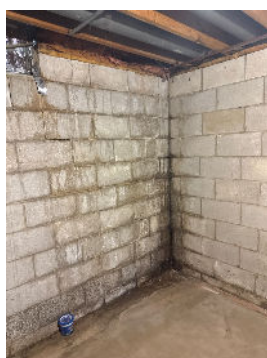
1.2. Evidence of a water intrusion/issue on the foundation wall (see picture). Recommend a professional basement specialist to assess and repair the water intrusion.

Active moisture intrusion along the entire north wall

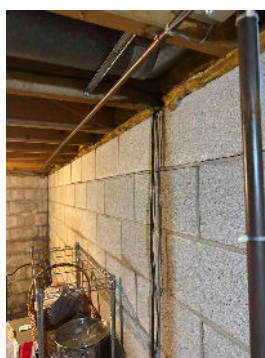
Small horizontal settling cracks long the east wall

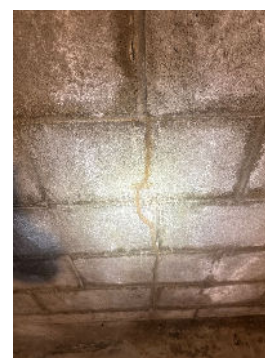
Termite tube observed on the north wall

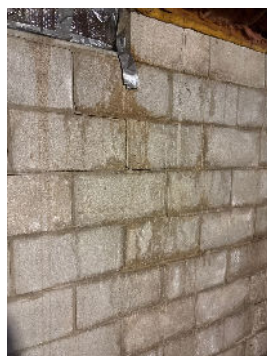
Stair stepping crack on the northeast corner

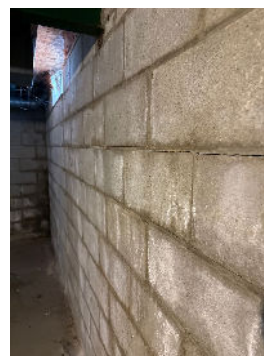
Horizontal settling cracks long the north wall

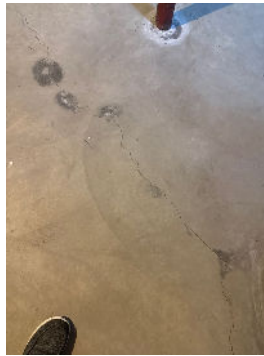
Common settling cracks noted

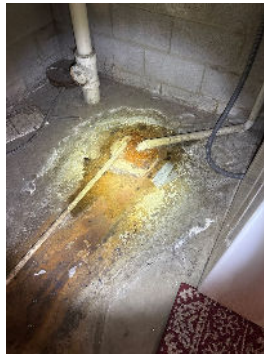
Standing water observed around the gravity drain

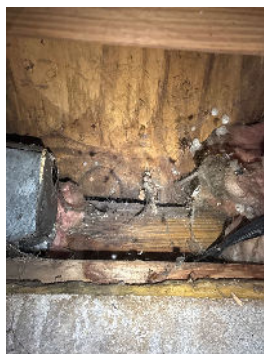
4.1. Not fully visible due to lack of access from ducting, plumbing, electrical.  
 4.2. Evidence of wood destroying organism damage (see pictures). There is visible damage to the structural components of the home (ie; sill plate, rim joist, floor joists etc...). Recommend a professional contractor to assess the extent of the damage and repair all effected areas. Additionally, the infestation does not appear that the infestation is active at the time of the inspection. However, we recommend contacting a professional pest control specialist to asses and treat the home to prevent future infestations.

Termite damaged framing and subfloor on the north wall

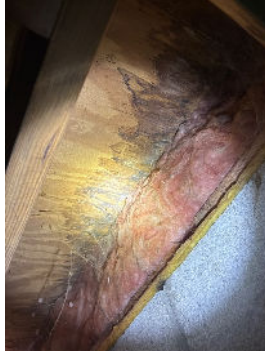
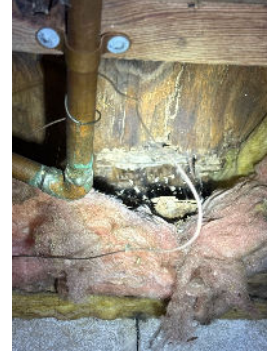
- 5.1. Not fully visible due to lack of access from ducting, plumbing, electrical.  
5.2. Mold like substance observed on the basement structure. Recommend testing the area to ensure the levels of mold then contact a qualified mold mitigation specialists to mitigate if necessary.

Mold like substance observed along the north wall    Heavily damaged sub floor from termites on the northeast corner

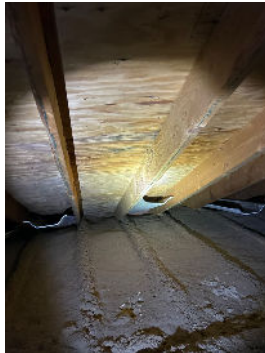
2.3. Rotten roof decking is observed (see picture). Recommend a professional contractor to repair/support the area(s).

Evidence of previous moisture damage on decking on west side of attic

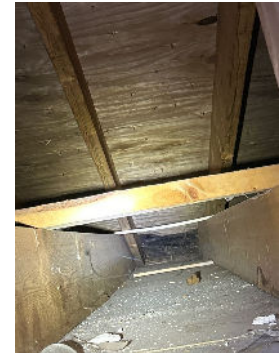
Evidence of previous moisture damage and rotten decking at the eaves in garage portion of attic

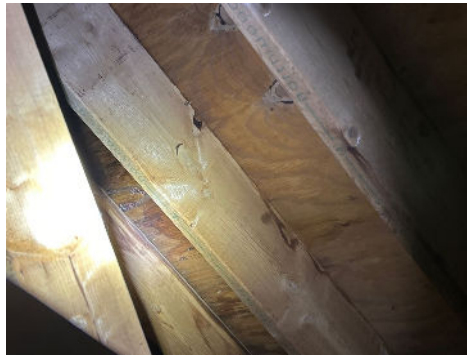
Evidence of previous moisture damage on decking in garage attic

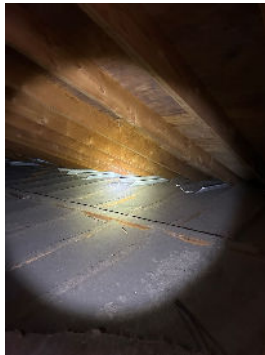
Majority of soffit baffles were not secured

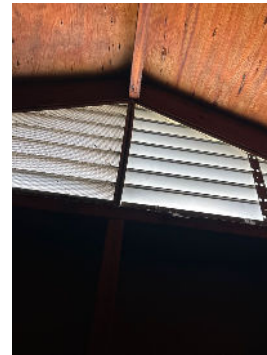
3.3. Missing gable end vent screen. Recommend installing a new gable end screen to prevent animal intrusion.

Gable end vent screen was missing on one side

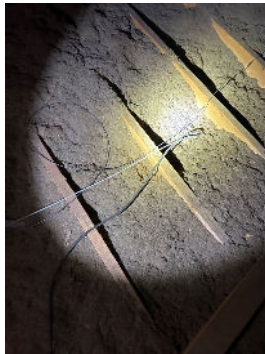
7.2. Missing insulation observed (see picture). Recommend adding additional insulation in this area for increased home efficiency.

Multiple areas of minimal/missing insulation observed

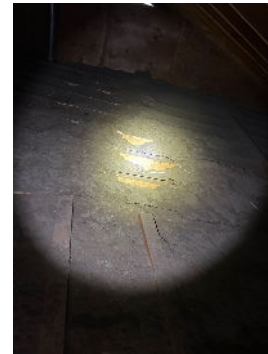
Additional evidence

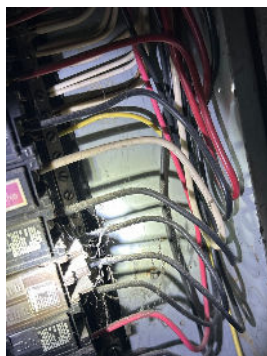
Unmarked neutral being used as hot feed in right side of panel

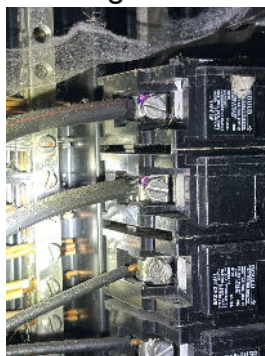
4.5. Aluminum wiring observed going to the breakers without any anti-corrosion paste being installed. Recommend having anti-corrosion paste installed on each aluminum wiring connection by a professional electrician.  
Note: any aluminum wiring should be assessed by a professional electrician.

Missing anti corrosion paste

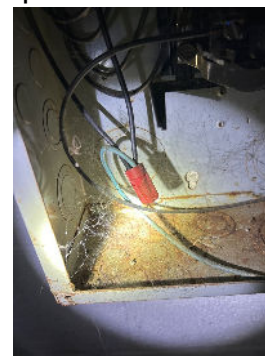
Triple tapped cable feed in bottom left side

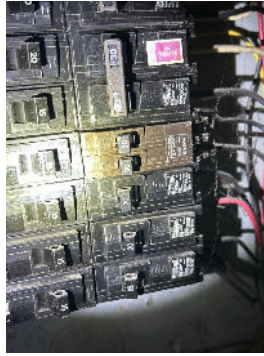
5.1. The particular electrical panel does not accept split mini breakers per the panel cover. Recommend having an electrical contractor remove the split mini breakers and install the individual pull breakers in their locations.

Split mini breaker observed in panel. This panel doesn't accept this style breaker.

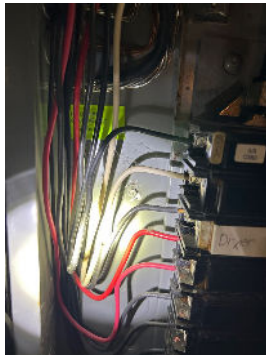
Unmarked neutral being used as a hot feed

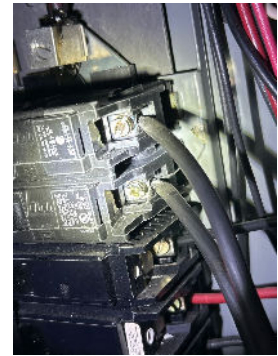
4.5. Aluminum wiring observed going to the breakers without any anti-corrosion paste being installed. Recommend having anti-corrosion paste installed on each aluminum wiring connection by a professional electrician. Note: any aluminum wiring should be assessed by a professional electrician.

Missing anti corrosion paste observed
