# PROPERTY INSPECTION REPORT

**NA, NA, OH NA**

CLIENT: Sam Sample

DATE OF INSPECTION: 10/6/2025

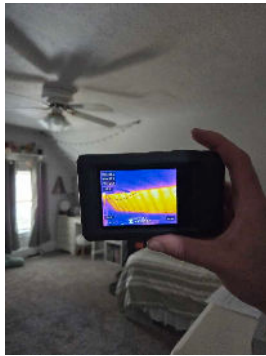
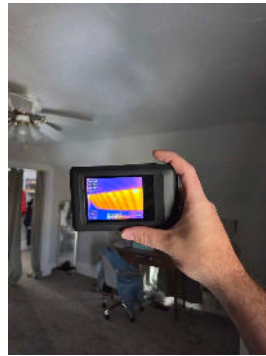
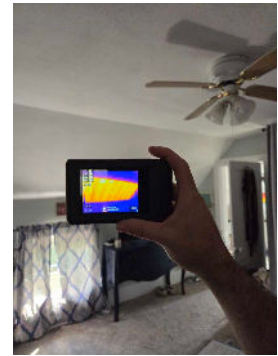
2.1. The infrared camera detects areas where insulation is missing, inadequate, or improperly installed. This can result in energy loss, temperature inconsistencies, and increased heating or cooling costs. Recommend adding or replacing insulation to ensure consistent temperature regulation and energy efficiency.

2.2. The infrared camera shows areas where air leaks may be present, particularly around windows, doors, and vents. These temperature differences can point to inadequate sealing or gaps in the building envelope, leading to drafts and energy inefficiency. Recommend sealing gaps and improving weatherstripping to prevent air loss.

These photos are evidence of areas of energy loss observed from interior of home.

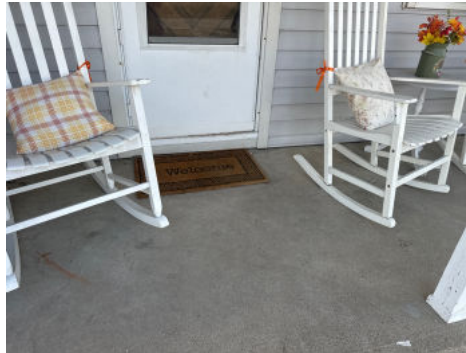
2.3. The porch cap has not been sealed properly to the home. Recommend sealing the porch cap to the home to prevent a moisture intrusion.

Front porch concrete needs sealed to home

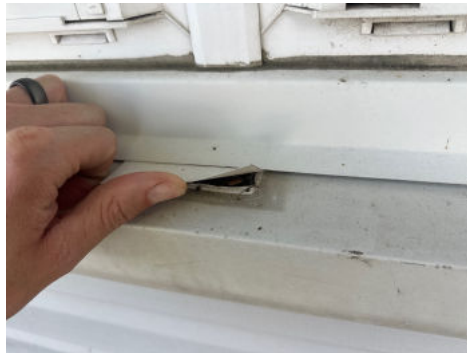
2.1. Majority of the window(s) are no longer properly sealed to the siding/trim. Recommend removing the old caulk/sealant and seal the window(s) to the siding/trim to prevent a potential moisture intrusion. (Note: in certain applications this is not a necessity. Such as newer construction home)

Improper trim repairs at windows

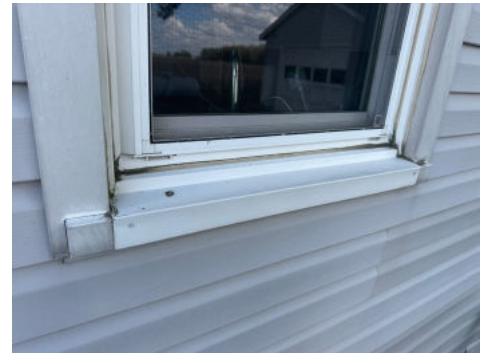
Additional evidence

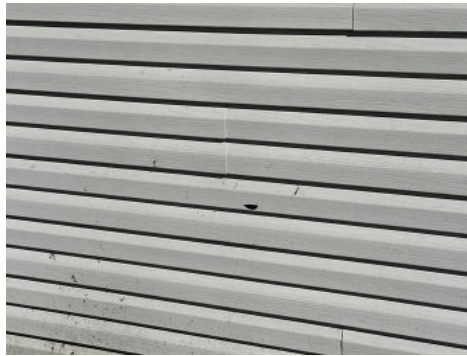
3.1. There are damaged piece(s) of siding on the exterior of the home. Recommend replacing the damage piece(s) to keep the substrate protected.

Damaged pieces of siding observed

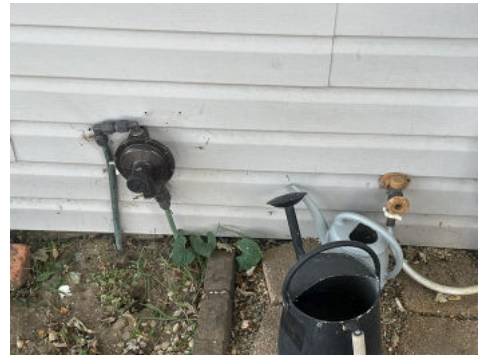
3.2. The intrusion(s) through the siding are not sealed to the siding. Recommend using a silicone based sealant around the intrusions to prevent any moisture intrusion. NOTE: using a silicone based sealant helps keep areas sealed while the house expands and contracts through the seasons.

3.3. The hole(s) in the siding are not sealed. Recommend using a silicone based sealant to seal the noted areas. NOTE: using a silicone based sealant helps keep areas sealed while the house expands and contracts through the seasons.

Siding penetrations and holes need sealed up at all times

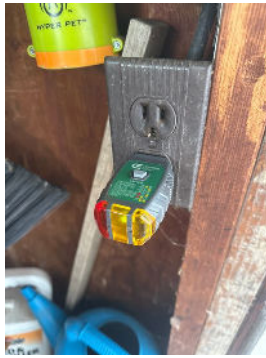
4.1. \*\*\*OUTLETS\*\*\*  
 4.2. Some outlets were not accessible at the time of the inspection due to homeowners belongings.  
 4.3. Open ground (or 2-wire) outlets present. This means that the 3rd (round) part of an appliance plug is not getting ground protection. This may be a concern with items such as computers and electronic devices. Recommend converting the outlet back to a 2 prong outlet or ground the outlet(s) with a GFCI protected outlet/breaker.  
 4.4. It is recommended to avoid use of multiplier outlet plug ins (converts 2 into 6 outlets). This can overload the circuit that was original designed for the style with only 2 outlets.  
 4.5. \*\*\*JUNCTION BOX\*\*\*  
 4.6. Missing junction box cover plate(s). Recommend installing new junction box cover plate(s), this is an easy and low cost repair for improved safety.

Open grounded outlets

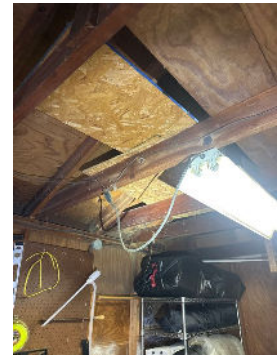
Improper extension cord power

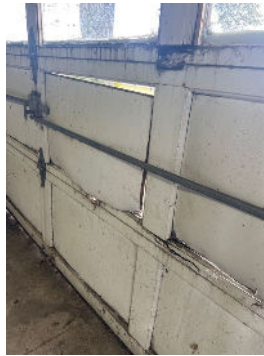
7.1. The garage door panel(s) are damaged (see pictures). The damaged panels are affecting the operation of the garage door and should be replaced.

Garage door is rotten and damaged, In need of replacement.

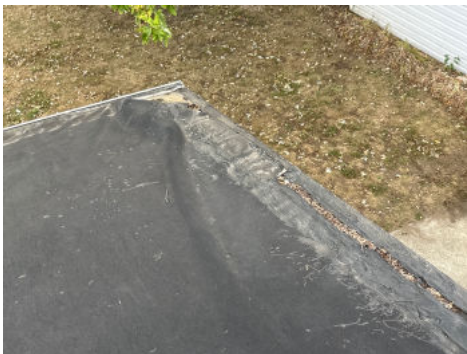
Rear rubber roof is damaged and needs replaced

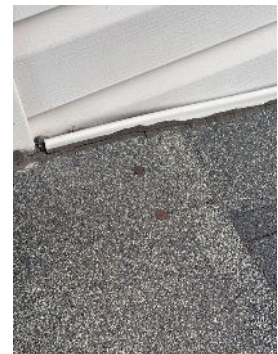
1.6. Exposed roofing nail(s). Recommend sealing the exposed nail head(s) with roofing tar. NOTE: the reason nail heads should be sealed is they will eventually rust through allowing water to seep into the attic areas.

Unsealed fasteners

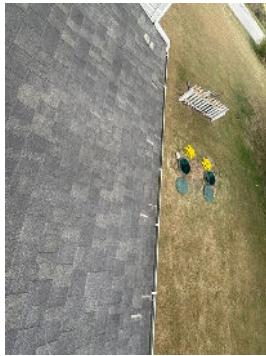
1.7. The roof has been improperly repaired (see pictures). Recommend having a professional roofing contractor properly repair the improperly repaired area(s).

Southwest corner improper shingle repairs

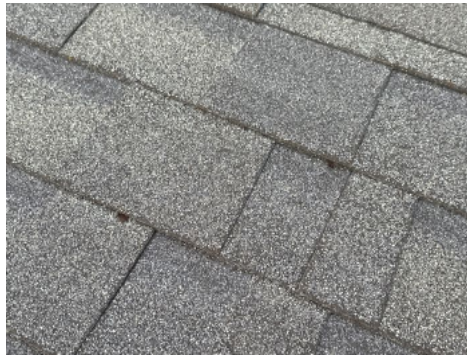
Low nails and granule loss observed

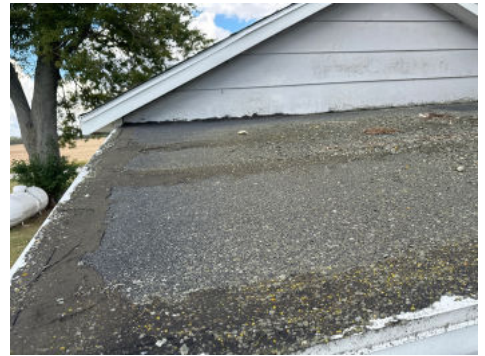
Improper tar repairs on backside of garage

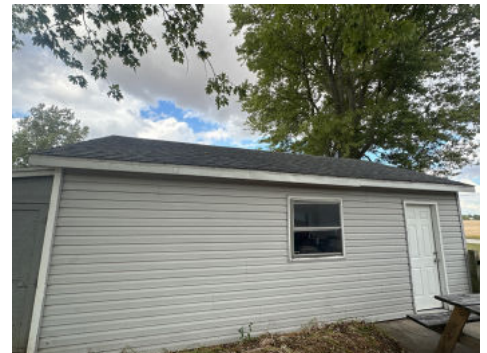
No gutters at garage observed

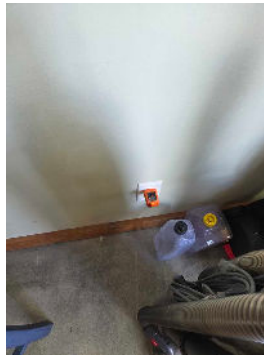
5.3. Open ground (or 2-wire) outlets present. This means that the 3rd (round) part of an appliance plug is not getting ground protection. This may be a concern with items such as computers and electronic devices.

Open ground observed in mud room

Recommend converting the outlet back to a 2 prong outlet or ground the outlet(s) with a GFCI protected outlet/breaker.

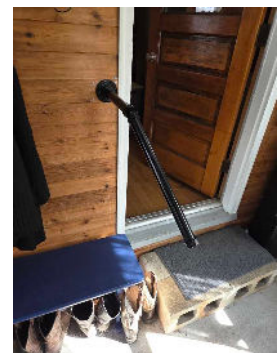
Loose handrail noted

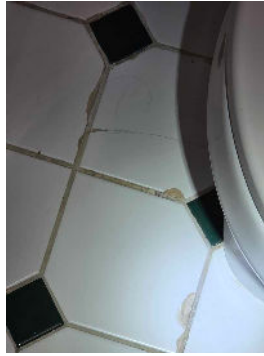
7.3. The tile(s) are cracked/damaged. Recommend removing and replacing any damaged tile(s).

Damaged tiles

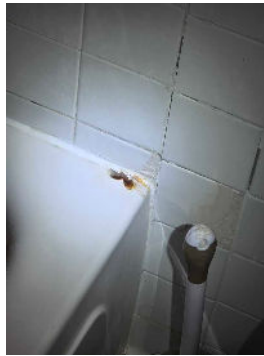
14.1. The finish on the tub is peeled/deteriorated.

Deteriorated tub finish

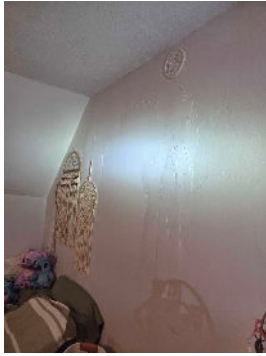
6.1. Improperly repaired section(s) of walls observed. Recommend properly repairing the section(s).

Poorly repaired section of wall observed

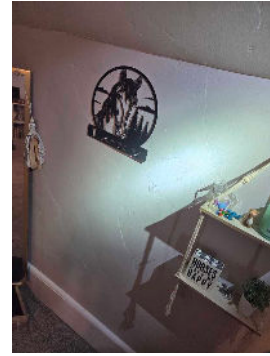
Additional evidence

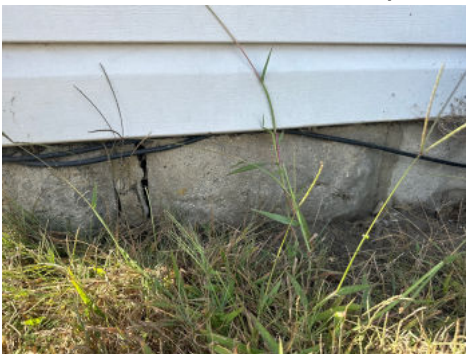
2.1. There are mortar joint cracks evident on the exterior of the home. Recommend removing any loose/damaged mortar and properly tuck point the needed area(s).

Mortar cracks observed at corners

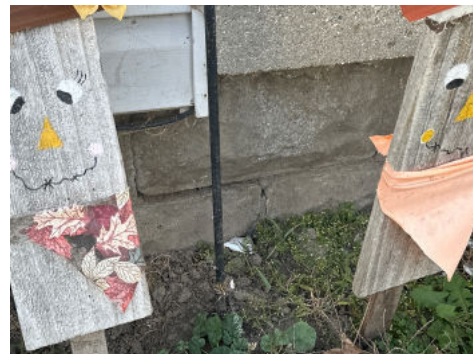
Cracked and loose mortar under front porch

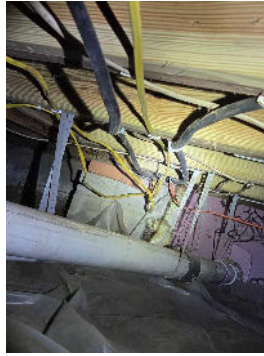
5.2. There were electrical wires hanging below the floor joists. Recommend encapsulating the wires in conduit or raise them into the floor joist system for improved safety.

Loose electrical observed

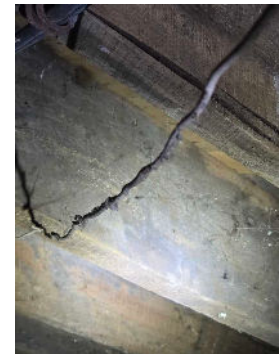
Mold like substance observed on floor joists

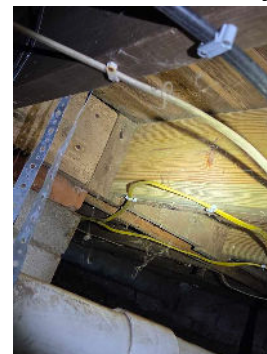
Missing joist hangers

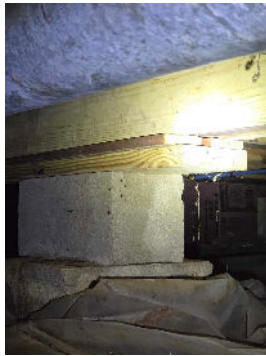
Wood shims observed under beam

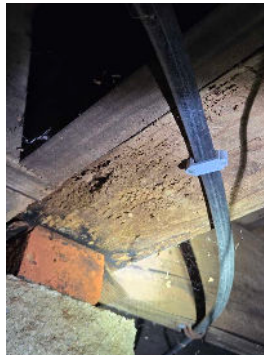
11.4. Evidence of wood destroying organism damage (see pictures). There is visible damage to the structural components of the home (ie; sill plate, rim joist, floor joists etc...). Recommend a professional contractor to assess the extent of the damage and repair all effected areas. Additionally, the infestation does not appear that the infestation is active at the time of the inspection. However, we recommend contacting a professional pest control specialist to asses and treat the home to prevent future infestations.

WDO damage observed on beam in center north end

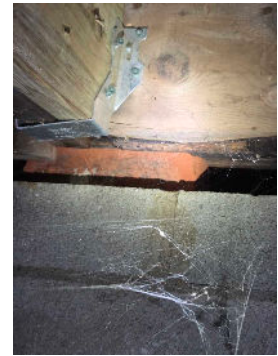
Rotten beam observed

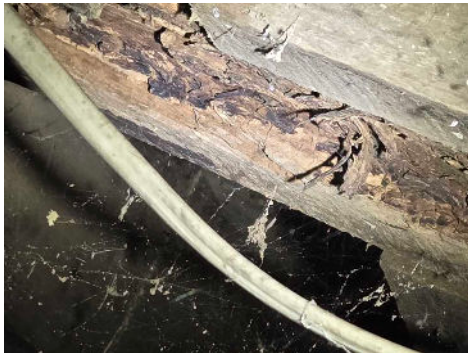
WDO damage observed

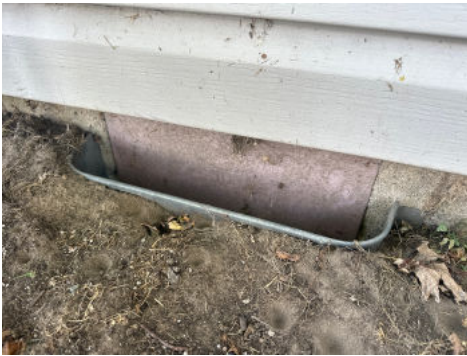
13.1. The crawlspace vent(s) have been blocked with debris. Recommend removing any foreign material from the vent to allow proper air flow for the crawlspace.

Vents have been blocked off

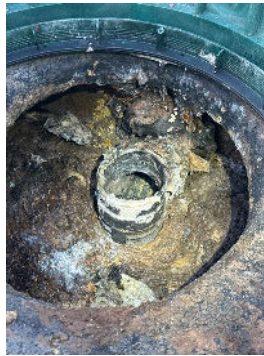
6.1. Clogging: Inlet baffles can become clogged with solid waste, debris, or grease over time. This can restrict the flow of wastewater into the septic tank, leading to backups and potential issues with the overall system.

T assembly was clogged upon arrival

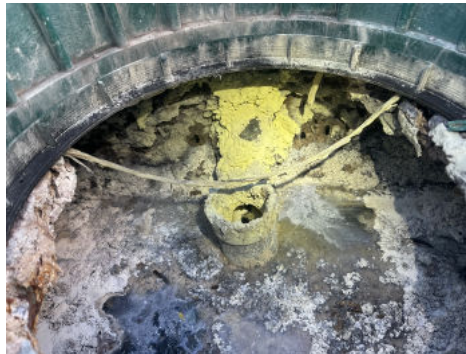
7.1. Damage or Deterioration: Outlet baffles, typically made of materials like PVC or concrete, can deteriorate over time due to exposure to wastewater and environmental conditions. Cracks, breakage, or general wear and tear can compromise the structural integrity of the baffles.

Significant deterioration at outlet end of tank

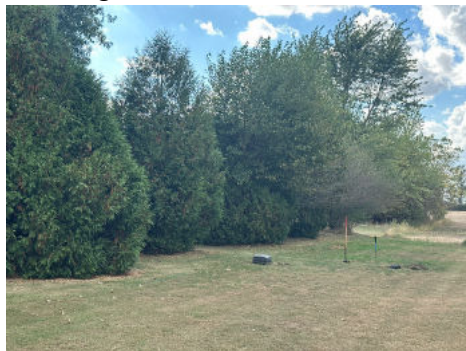
Dense vegetation on south end

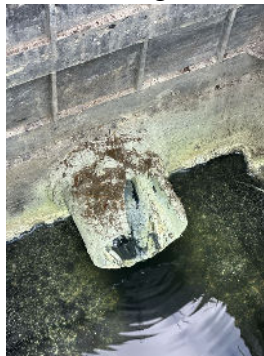
Cracked/damaged inlet pipe observed

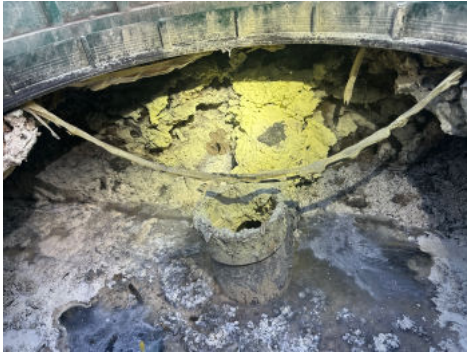
Significant deterioration observed within the concrete on the outlet end of tank. It is highly recommended to engage with a licensed septic contractor to evaluate the tank/system for replacement.

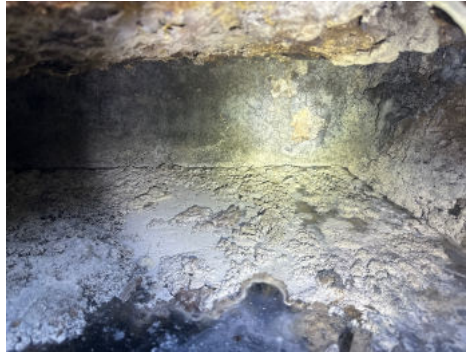
Evidence of deteriorated septic tank

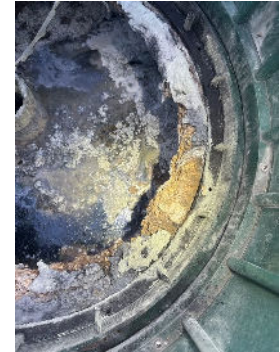
Additional evidence

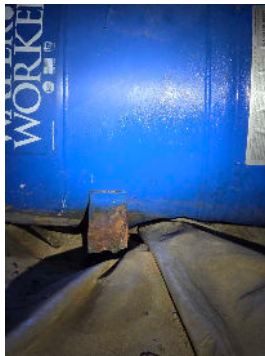
4.1. The rusted condition of the pressure tank enclosure indicates an aging tank. To address this and prevent potential issues, it is recommended to engage a qualified well contractor to replace the pressure tank. Replacing the older tank with a new one will help ensure the continued functionality and reliability of the well system. A qualified professional can assess the situation, recommend an appropriate replacement, and carry out the installation, promoting the efficient operation of the well system.

Corrosion observed on pressure tank.

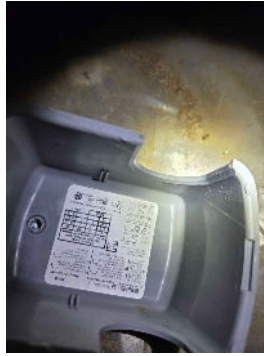
5.2. The installed pressure switch is set at 40/60, indicating that the well pump should turn on at 40 PSI and off at 60 PSI. However, the current pressure switch is not operating within these parameters, suggesting a malfunction. It is advisable to seek the expertise of a qualified well contractor to evaluate and, if necessary, repair or replace the pressure switch. This ensures proper functioning of the well pump and maintains the desired pressure levels in the system.

40/60 Pressure Switch.

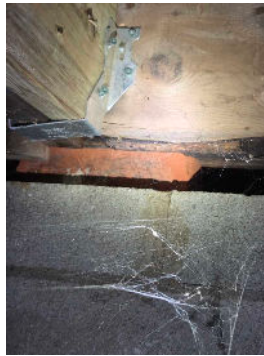
Rotten beam observed

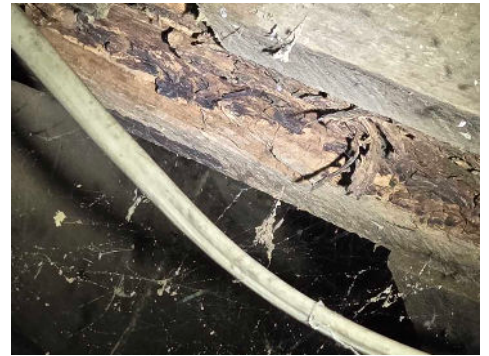
WDO damage observed

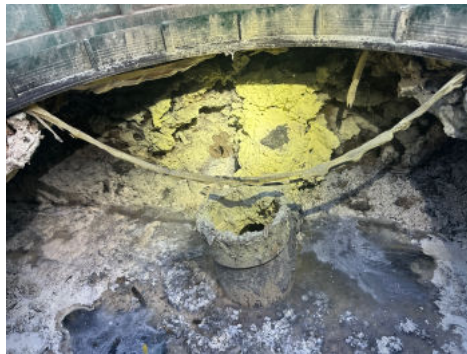
| Page 71 Item: 1 | Septic Tank Results |

Significant deterioration observed within the concrete on the outlet end of tank. It is highly recommended to engage with a licensed septic contractor to evaluate the tank/system for replacement.
