# PROPERTY INSPECTION REPORT

CLIENT: Sam Sample

INSPECTOR: Korey Pavlika

DATE OF INSPECTION: 9/24/2025

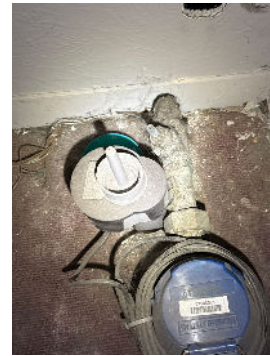
Missing shut off valve

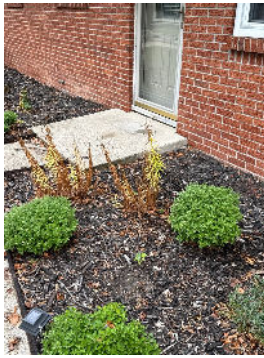
The front porch cap has sunk away from the home

2.2. The porch cap has sunk away from the home. We recommend having the porch cap raised back to its original location. This can typically be done with concrete pumping.

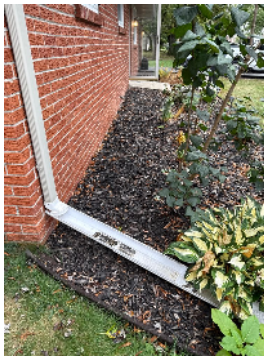
Negative grade on the northwest corner

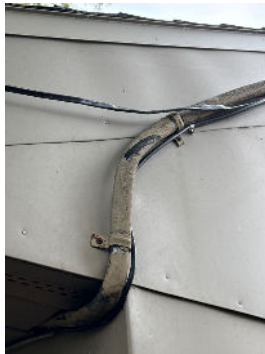
The service entrance wire insulation is deteriorated

6.3. The insulation/casing around the main service line to the meter socket is deteriorated/damaged. Recommend a qualified electrical contractor to repair or replace the insulation/casing.

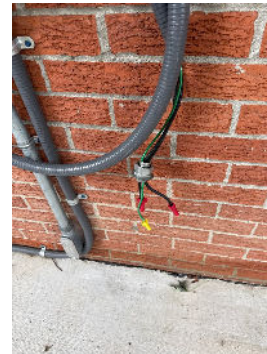
Exposed electrical wire ends on the southeast corner. This is for a hot tub hookup

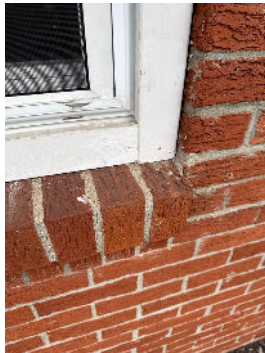
Multiple windows should be sealed again to the brick

2.1. Majority of the window(s) are no longer properly sealed to the siding/trim. Recommend removing the old caulk/sealant and seal the window(s) to the siding/trim to prevent a potential moisture intrusion. (Note: in certain applications this is not a necessity. Such as newer construction home)

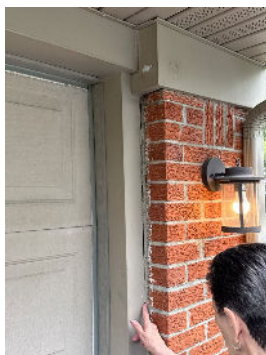
The trim around the garage door should be sealed again

3.1. There are area(s) of siding that is not sealed properly (see pictures). Recommend using a silicone based sealant to seal the noted areas. NOTE: using a silicone based sealant helps keep areas sealed while the house expands and contracts through the seasons.

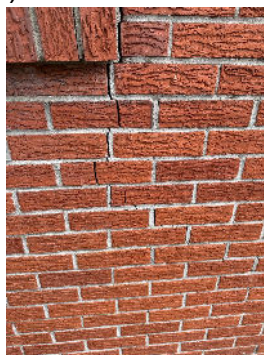
Mortar joint settling crack on the northeast corner

3.3. There are mortar joint cracks evident on the exterior of the home. Recommend removing any loose/damaged mortar and properly tuck point the needed area(s).

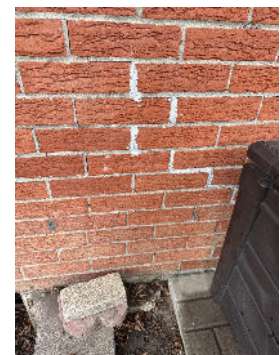
Minor settling crack on the northeast corner

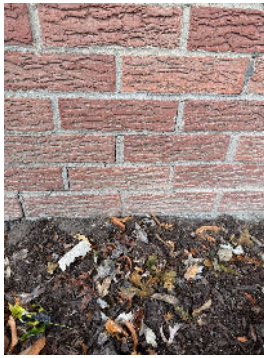
Hairline settling crack on the southeast corner

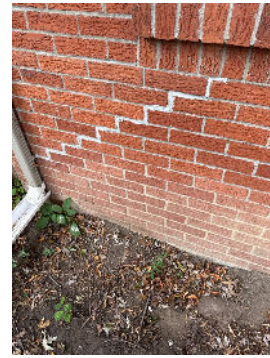
Repair observed on the southeast corner

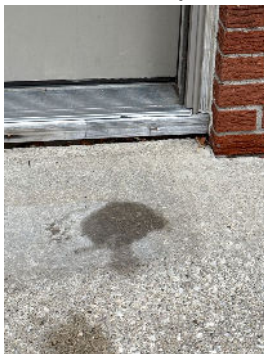
Small amount of chipped paint under the front entry door

6.1. There is evidence of chipped/peeling paint. Recommend scraping and then painting the areas as needed to protect the substrate.

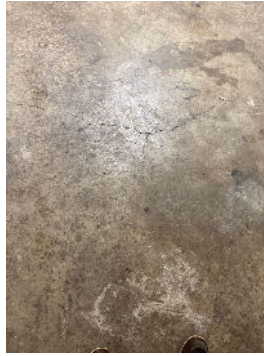
Common settling cracks observed

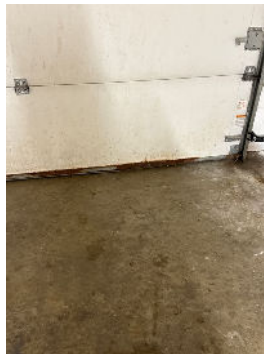
The bottom garage door panel has rusted/damaged

8.1. The garage door(s) are starting to rust/rot along the bottom. Recommend monitoring the doors condition for future replacement.

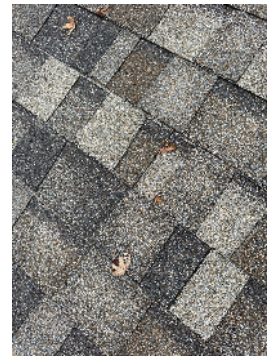
1.2. The shingles have been installed with an oversized exposure (see picture). The minimum exposure for shingles depends on the type of shingle and roofs slope, however most single manufacturers utilize 5 5/8 inches as their recommendation. This can lead to leaks, wind damage, premature shingle deterioration, water infiltration and potential void of manufacturers warranty.

There is a few rows with poor exposure of the shingles

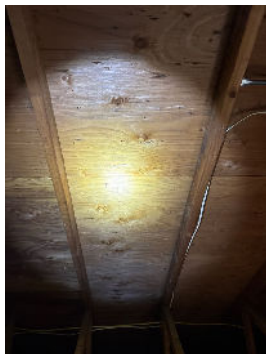
No H-clips installed on decking

3.2. Due to the rafters being 2 ft on center in the home/garage there should be plywood H-clips installed between the roof decking. This helps with deflection and expansion/contraction of the material.

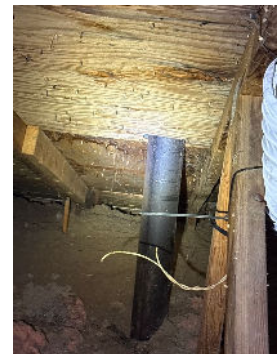
Additional evidence of previous moisture damage by soil stack

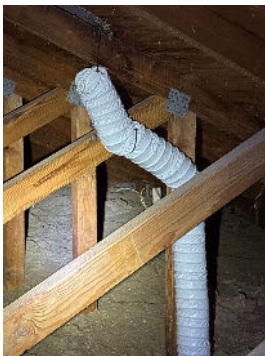
Exhaust vent terminates into attic

9.1. Exhaust vent(s) terminate into the attic. Exhaust vents should be terminated through the roof to ensure any moisture is not going into the attic areas.

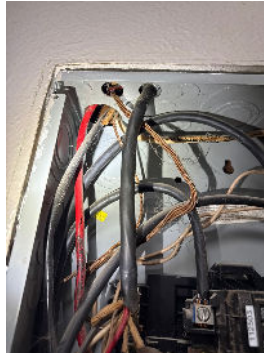
Missing romex connectors throughout the panel

4.1. Missing romex connector(s) at the point of entry for the wire(s). Recommend installing the correct romex connector(s) to protect the casing of the wire from getting stripped.

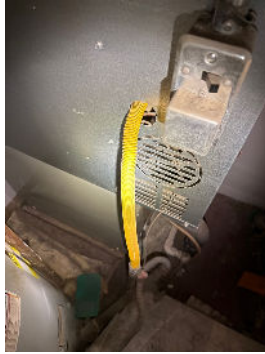
The gas line entering the furnace must be hard piped

6.2. The gas line as it enters the furnace cabinet is not hard piped and is currently utilizing a flexible gas line connection. This connection should be replaced with new hard piped material for improved safety. Hard piped gas lines have increased durability, fire resistance and help avoid gas leaks.

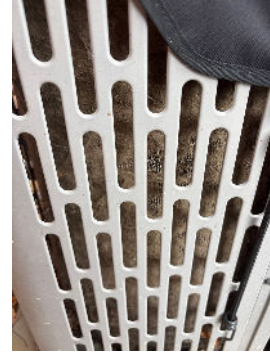
High amount of debris observed on fins. Recommend having unit cleaned/serviced.

1.1. It appears the AC unit has not been serviced in quite some time. Recommend a professional HVAC contractor to service the AC unit.

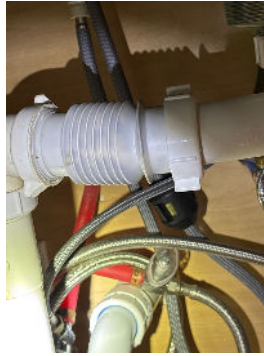
Flex drain observed for sink

8.2. A flexible (accordion-style) drain line was observed under the sink. While commonly used for quick installations, these types of drains are more prone to clogging due to their ribbed interior surface and are generally not recommended by plumbing standards for long-term use. Replacement with a smooth-walled, rigid drain pipe is recommended for improved durability and proper drainage.

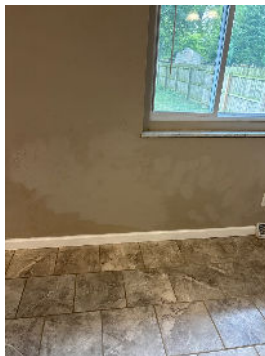
Poor repairs/paint job done on back wall

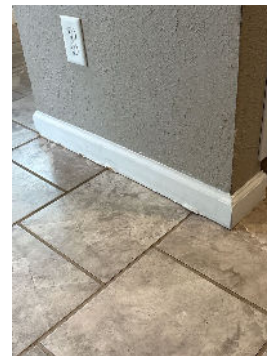
Damaged trim around cabinetry

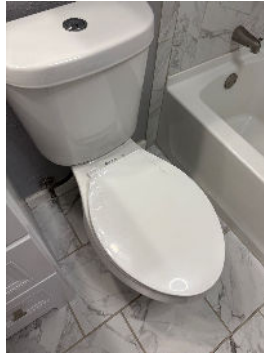
Toilet was slightly loose and will need secured

17.1. Toilet is loose from the floor. Recommend securing the toilet to the floor. These bolts are located along the bottom side of the toilet. Most of the time these will just need to be tightened.

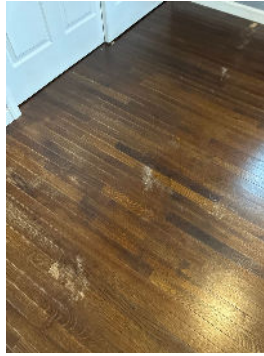
Worn/scratched flooring observed

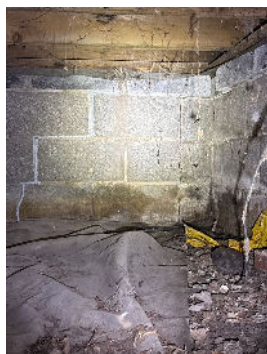
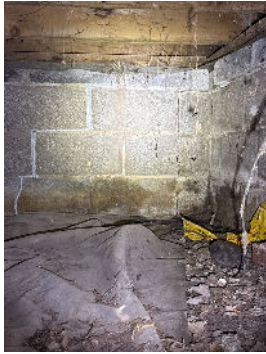
Significant shift in the foundation block on the north east corner

1.5. There is a shift in the block (see picture). This means that the block has shifted away from the remaining blocks of the home. Recommend a professional masonry contractor to assess the severity of the shift for proper repairs.

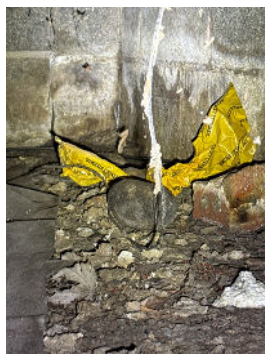
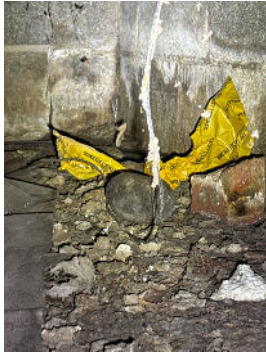
Active moisture intrusion on the northeast corner

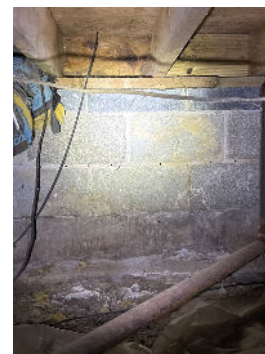
Wood destroying organisms treatment on the northwest corner

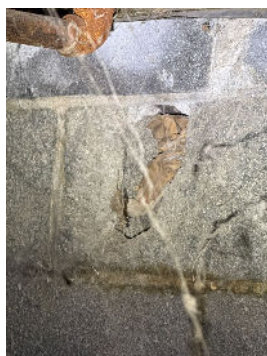
Damaged foundation block on the northwest corner

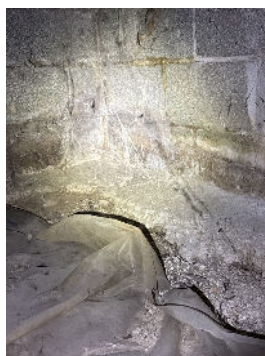
Efflorescence observed along the inside perimeter of the foundation

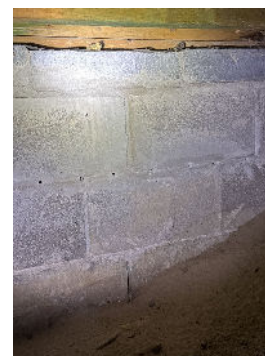
Additional evidence of wood destroying organism damage along the interior foundation

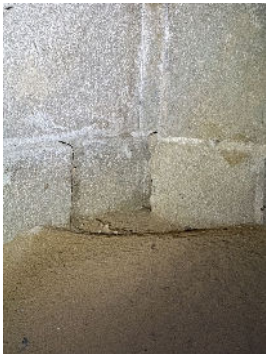
Separation in the block on the southwest corner

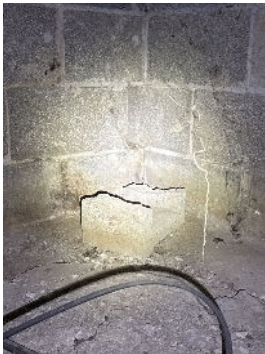
Pulled out/missing block on the south wall

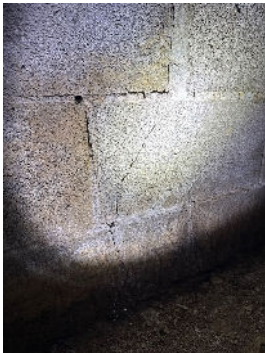
Settling crack observed on the east wall

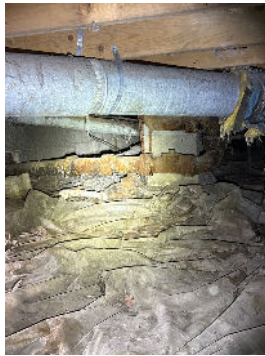
Improperly tapered main drain line

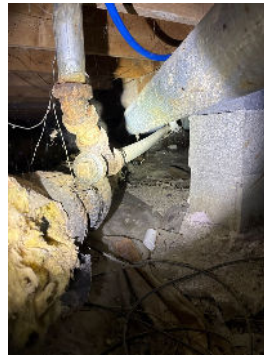
Improperly tapered drain line

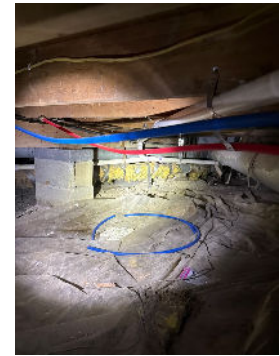
Loosely hanging supply lines observed

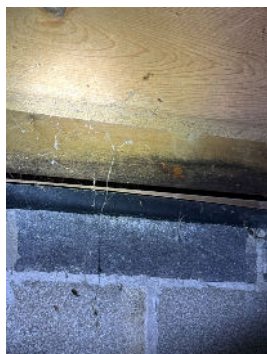
Mold like substance observed on the framing material on the northwest corner

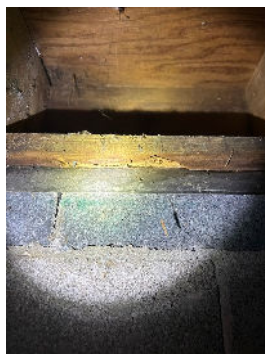
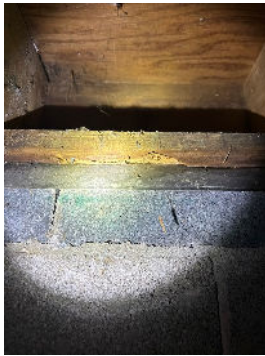
Heavily damaged sill plate from wood destroying organisms along the west wall. Approximately 8-10 ft worth

9.8. Evidence of wood destroying organism damage (see pictures). There is visible damage to the structural components of the home (ie; sill plate, rim joist, floor joists etc...). Recommend a professional contractor to assess the extent of the damage and repair all effected areas. Additionally, the infestation does not appear that it is active at the time of the inspection. However, we recommend contacting a professional pest control specialist to asses and treat the home to prevent future infestations.

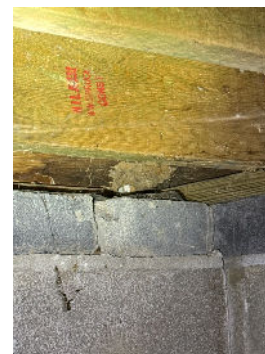
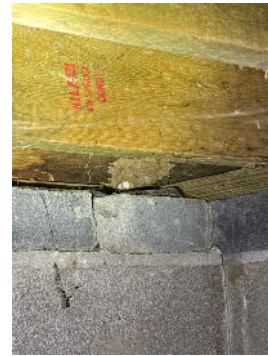
Non existent rim joists and damaged floor joist on the southwest corner

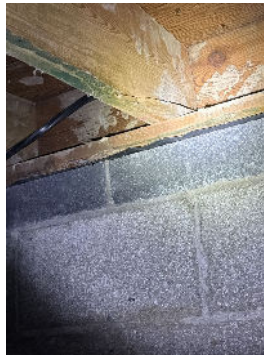
Cracked floor joist end on the east wall

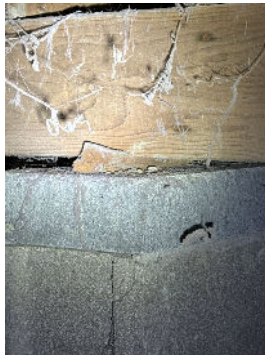
Multiple sections of beams have been shimmed with wood than have crushed

12.2. The beam has not been supported where the wood joins together, this can ultimately cause the beam to sag in these areas as it is a weak point in the beam. Recommend adding additional supporting posts/columns to adequately support the beam.

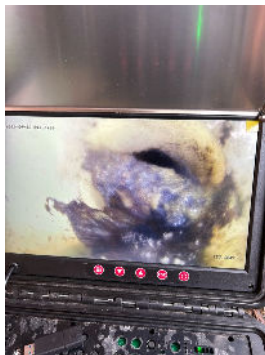
Large tree root observed to be growing into sewer line roughly 119 foot into scope. Recommend having line cleaned and further evaluated by a plumber to come up with proper repairs needed.

4.3. The inspection has revealed the presence of large tree root(s) within the scoped length, as evident in the provided video/pictures. It is strongly recommended enlisting the services of professionals to thoroughly clean the main drain line, removing all debris. This action is crucial to prevent potential disruptions in the drainage system of the home. Following the cleaning process, it is advised to conduct a re-scoping of the line to ensure the elimination of any remaining issues and verify the restored condition of the drain line.

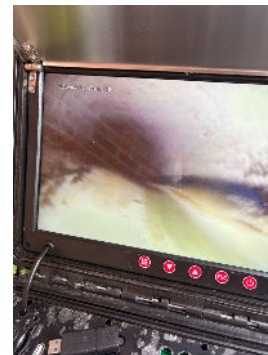
Portion of sewer line observed to be pushing the bottom side of the pipe upwards. Could be due to roots growing around line.
