# PROPERTY INSPECTION REPORT

CLIENT: Sam Sample

INSPECTOR: Korey Pavlika

DATE OF INSPECTION: 7/22/2025

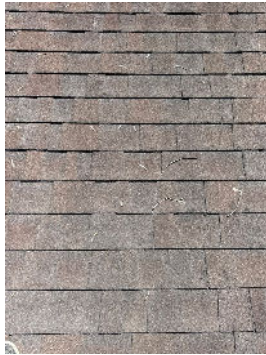
1.2. There are areas of granular loss (see pictures) indicating the roof is older. Recommend having a professional roofing contractor assess the roof for repairs/replacement.

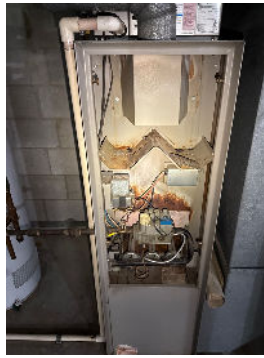
Current Condition

The furnace has exceeded its typical lifespan and is considered to be well beyond the expected service life. The system is likely to be inefficient and may experience frequent breakdowns or failures. Ongoing repairs may become increasingly costly, and energy efficiency will likely be very poor. Replacement is strongly recommended, as the furnace is unlikely to perform reliably for much longer. The inspector does not guarantee future performance and strongly advises consulting with an HVAC professional to evaluate replacement options as soon as possible.

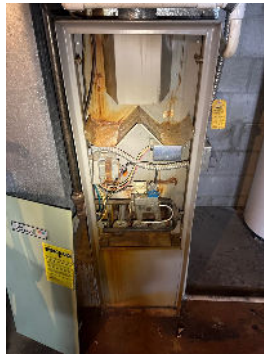
Current Condition

The furnace has exceeded its typical lifespan and is considered to be well beyond the expected service life. The system is likely to be inefficient and may experience frequent breakdowns or failures. Ongoing repairs may become increasingly costly, and energy efficiency will likely be very poor. Replacement is strongly recommended, as the furnace is unlikely to perform reliably for much longer. The inspector does not guarantee future performance and strongly advises consulting with an HVAC professional to evaluate replacement options as soon as possible.

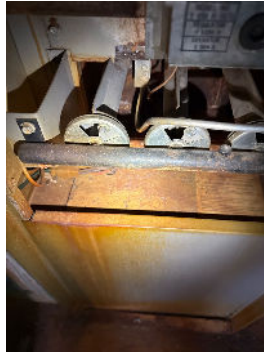
1.1. Corrosion build up observed on the inside of the furnace. Recommend a professional HVAC contractor to assess for repairs.

Heavy corrosion observed throughout the unit

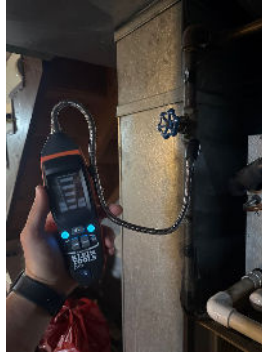
5.1. No drip leg installed on the gas supply line. Recommend having a drip leg installed after the shut off valve so it can be easily serviced.

Gas Reading. No leak detected at the time of inspection.

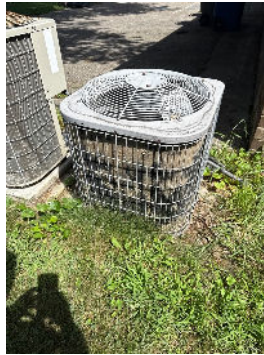
Current Condition

1.1. It appears the AC unit has not been serviced in quite some time. Recommend a professional HVAC contractor to service the AC unit.

The AC unit is nearing the later stages of its typical lifespan, which may lead to more frequent repairs and reduced efficiency. The system may require more attention, and an HVAC professional may be needed to assess the need for an upgrade or replacement. The inspector does not guarantee future performance and recommends considering a replacement soon.

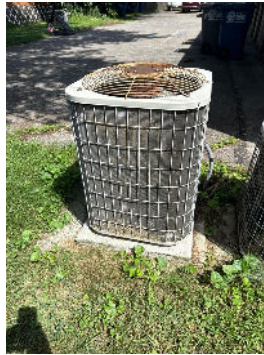
Current Condition

1.1. It appears the AC unit has not been serviced in quite some time. Recommend a professional HVAC contractor to service the AC unit.

The AC unit is nearing the later stages of its typical lifespan, which may lead to more frequent repairs and reduced efficiency. The system may require more attention, and an HVAC professional may be needed to assess the need for an upgrade or replacement. The inspector does not guarantee future performance and recommends considering a replacement soon.

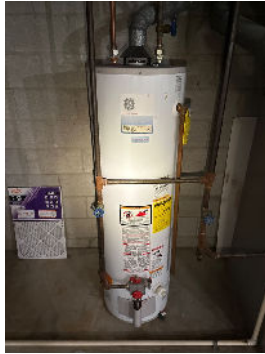
Current Condition

The water heater is nearing or exceeding its typical lifespan. Repairs may become more frequent, and energy efficiency will likely be significantly reduced. The unit may start to show signs of wear, such as leaks, rust, or inconsistent heating. The inspector advises planning for a replacement soon and suggests consulting with a plumbing professional for an assessment.

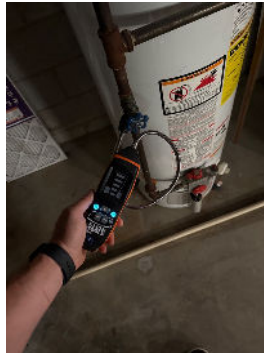
8.1. No drip leg installed on the gas supply line. Recommend having a drip leg installed after the shut off valve so it can be easily serviced.

Gas Reading. No leak detected at the time of inspection.

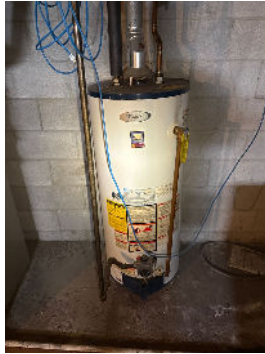
Current Condition

1.2. 15 - 20 Years Old.

The water heater is nearing or exceeding its typical lifespan. Repairs may become more frequent, and energy efficiency will likely be significantly reduced. The unit may start to show signs of wear, such as leaks, rust, or inconsistent heating. The inspector advises planning for a replacement soon and suggests consulting with a plumbing professional for an assessment.

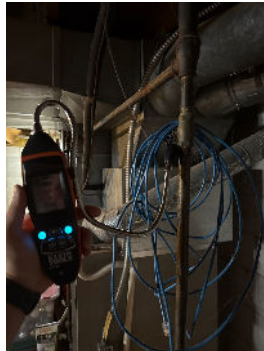
8.1. No drip leg installed on the gas supply line. Recommend having a drip leg installed after the shut off valve so it can be easily serviced.

Gas Reading. No leak detected at the time of inspection.

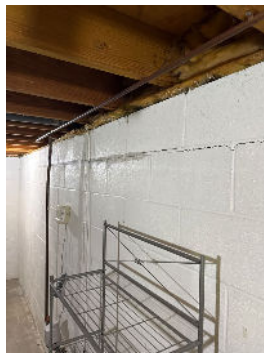
1.4. Diagonal stair stepping settling crack that is wider along the top and slimmer along the bottom of the crack. This means that the foundation may be settling allowing these types of cracks to show up. These cracks can allow water to intrude into the home and may be expanding and contracting in response to the weather. Recommend a basement professional to assess the severity and provide any solutions/repairs needed.

Small horizontal settling cracks long the east wall

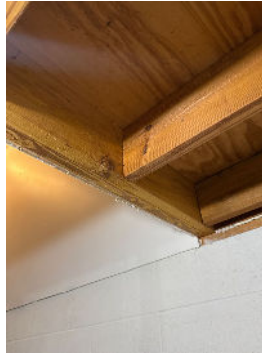
Missing joist hangers at the bottom of the staircase

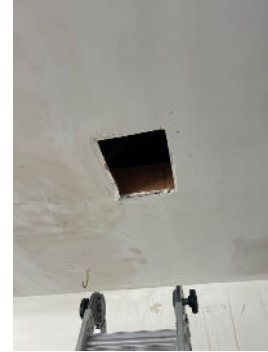
Access Point for garage attic. Very limited access to due opening size.

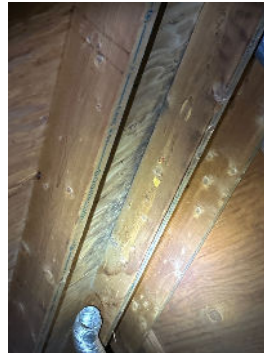
2.2. Mold like substance observed on the underside of the roof deck. Recommend testing the area to ensure the levels of mold then contact a qualified mold mitigation specialists to mitigate if necessary.

Mold like substance observed on decking by exhaust vent

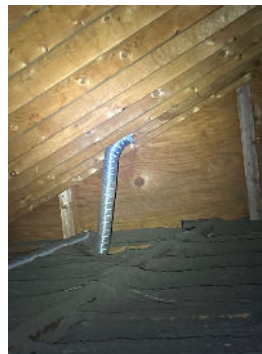
8.1. Exhaust vent(s) terminate into the attic. Exhaust vents should be terminated through the roof to ensure any moisture is not going into the attic areas.

Exhaust vent terminates into attic

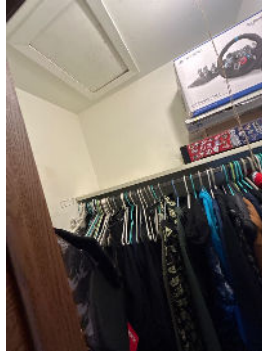
Very limited access to upper attic due to homeowners belongings.

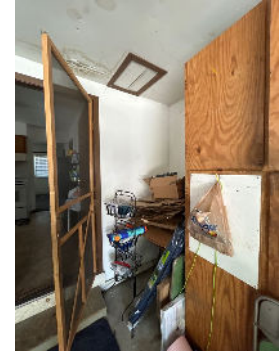
Access panel was not able to be opened due to homeowners belongings

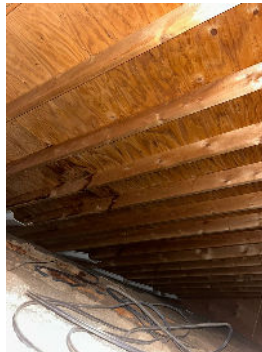
2.1. Evidence of previous moisture damage (was confirmed dry at the time of inspection using a moisture meter). Note: we still recommend verifying the area is dry prior to closing.

Evidence of previous moisture damage on decking on east side of attic. Couldn't be reached for testing.

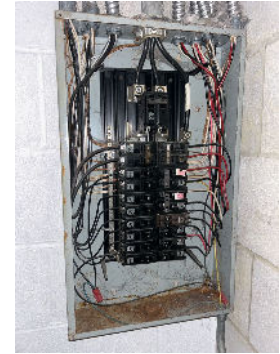
Current Condition

1.1. Corrosion observed inside of the electrical panel. This is caused by a moisture issues either inside of the home or seeping from the outside of the home. Recommend a professional electrical contractor to assess and repair/replace any components deemed necessary.

1.2. Some of the individual breakers inside the electrical panel has not been labeled. This ensures breakers can be safely turned on/off while working on separate circuits. Recommend having the electrical panel labeled for improved safety.

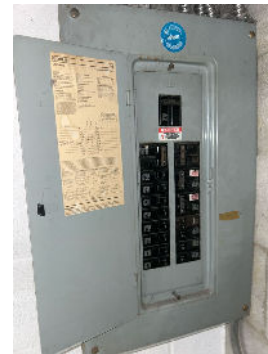
Corrosion observed in panel

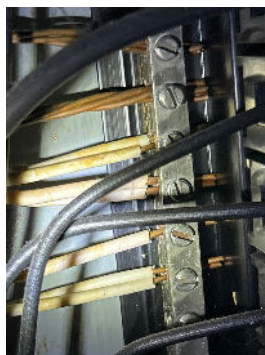
4.1. There are multiple neutral wires attached to the same lug in the electrical panel. Recommend a qualified electrical contractor to separate each neutral wire onto its own neutral lug (see picture). The reason neutrals cannot be shared is the circuit cannot be isolated if it needs to be worked on and the connections can become loose in which can lead to a fire hazard.

Multiple neutrals under same lug

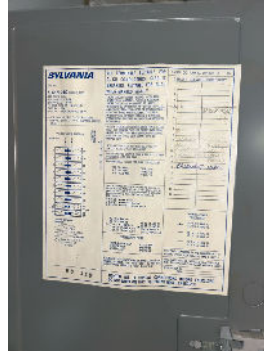
1.1. The individual breakers inside the electrical panel has not been labeled. This ensures breakers can be safely turned on/off while working on separate circuits. Recommend having the electrical panel labeled for improved safety.

Electrical Panel Label

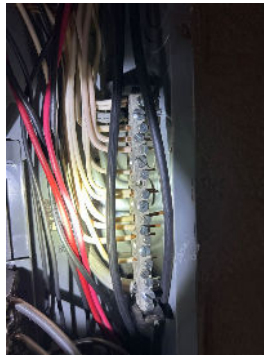
4.1. There are multiple neutral wires attached to the same lug in the electrical panel. Recommend a qualified electrical contractor to separate each neutral wire onto its own neutral lug (see picture). The reason neutrals cannot be shared is the circuit cannot be isolated if it needs to be worked on and the connections can become loose in which can lead to a fire hazard.

Multiple neutrals under same lug

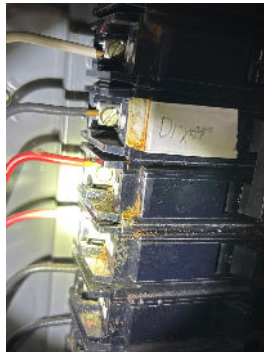
5.1. Corrosion observed on the breakers (see picture). Recommend a professional electrical contractor to assess and repair/replace the breakers.

Corrosion observed on breakers

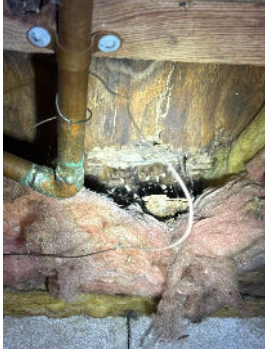
| Page 36 Item: 5 | Sub floor | <p>Heavily damaged sub floor from termites on the northeast corner</p> |
