# PROPERTY INSPECTION REPORT

**NA, NA, OH NA**

CLIENT: Sam Sample

DATE OF INSPECTION: 10/6/2025

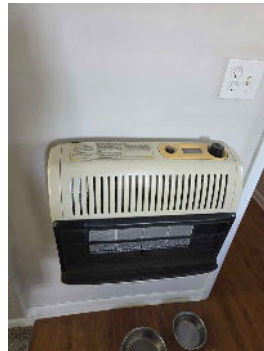
Supplemental heating observed in home.

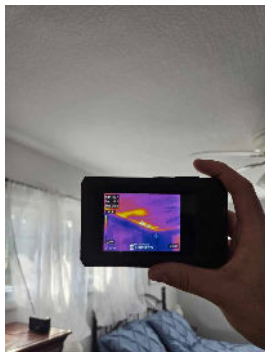
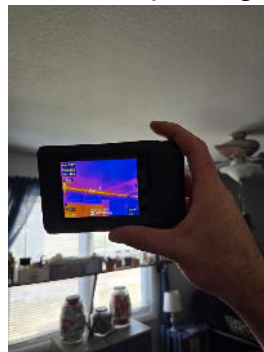
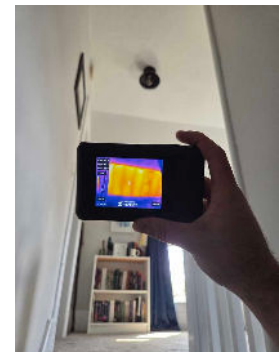
2.1. The infrared camera detects areas where insulation is missing, inadequate, or improperly installed. This can result in energy loss, temperature inconsistencies, and increased heating or cooling costs. Recommend adding or replacing insulation to ensure consistent temperature regulation and energy efficiency.

2.2. The infrared camera shows areas where air leaks may be present, particularly around windows, doors, and vents. These temperature differences can point to inadequate sealing or gaps in the building envelope, leading to drafts and energy inefficiency. Recommend sealing gaps and improving weatherstripping to prevent air loss.

2.3. Areas of temperature inconsistency detected by the infrared camera may suggest poor ventilation, particularly in attics, crawlspaces, or other enclosed areas. This can lead to moisture buildup, mold growth, and energy inefficiency. Recommend improving ventilation and airflow in affected areas.

These photos are evidence of areas of energy loss observed from interior of home.

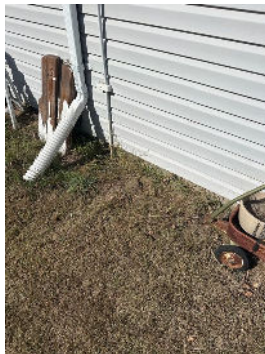
3.1. Lot grading and drainage have a significant impact on the building, simply because of the direct and indirect damage that moisture can have on the foundation. It is very important, therefore, that surface runoff water be adequately diverted away from the home. Lot grading should slope away and fall a minimum of one (1) inch every foot for a distance of six (6) feet around the perimeter of the building.

Low grading observed around home

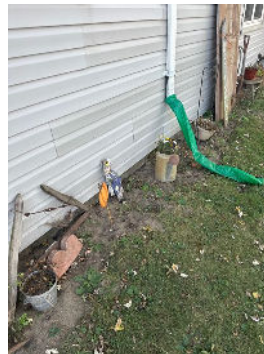
Additional evidence

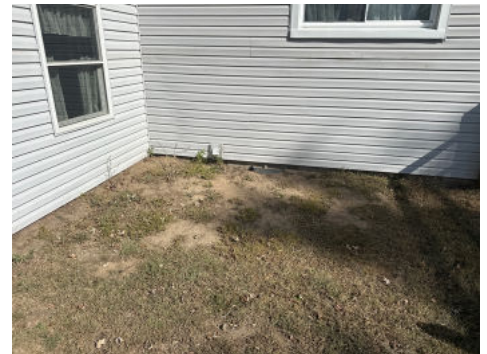
Additional evidence

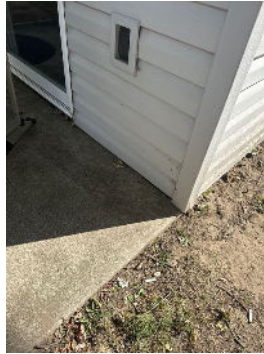
5.2. The patio(s) are not properly sealed to the home. Recommend sealing the patio(s) to the home.

Patio and or north concrete needs sealed to home

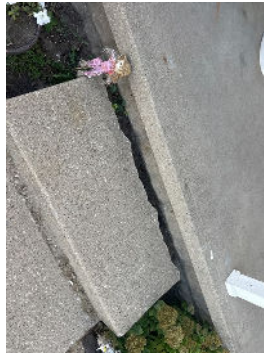
Front step needs sealed to home

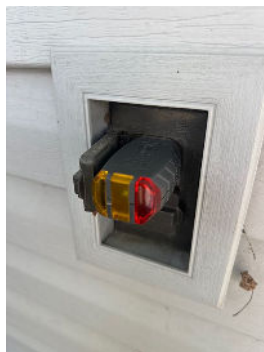
7.2. Open ground (or 2-wire) outlets present. This means that the 3rd (round) part of an appliance plug is not getting ground protection. Recommend converting the outlet back to a 2 prong outlet or ground the outlet(s) with a GFCI protected outlet/breaker.

Open grounded outlets observed at exterior plugs.

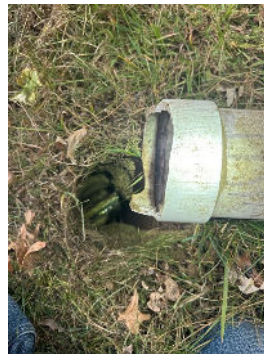
Cleanout to septic tank is broken/loose

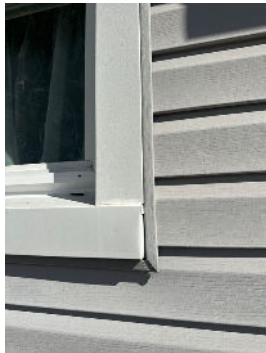
2.1. Majority of the window(s) are no longer properly sealed to the siding/trim. Recommend removing the old caulk/sealant and seal the window(s) to the siding/trim to prevent a potential moisture intrusion. (Note: in certain applications this is not a necessity. Such as newer construction home)

Windows need sealed to perimeter trim

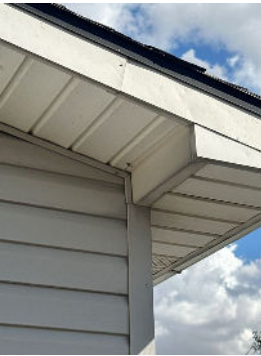
3.5. Transitions in the siding trim are not sealed (see picture). We recommend sealing these areas with a siliconized based caulk to prevent potential moisture intrusions.

Transitions at corners need sealed up

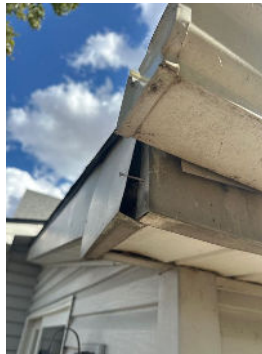
5.1. There are loose piece(s) of fascia on the home. Recommend securing the loose fascia to its substrate.

Loose trim observed at corners

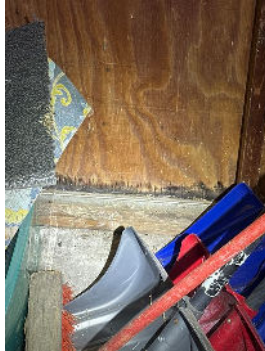
1.1. Evidence of moisture damage (wet at the time of inspection). Recommend a professional contractor to assess the areas of concern and make the necessary repairs to prevent further damage.

Active moisture observed at wall bottoms

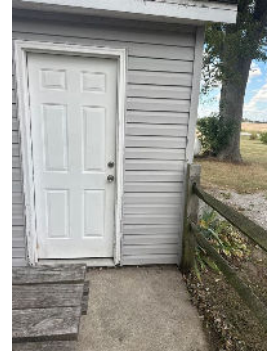
Loose wall observed at door.

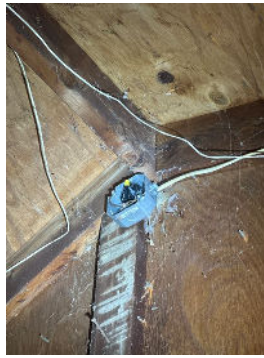
Exposed electrical

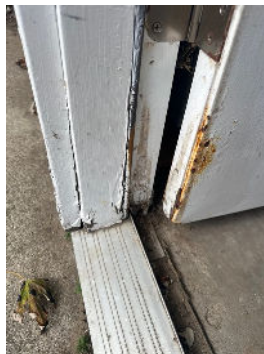
6.1. The garage service door(s) is rotted/rotting along the bottom of the jamb. Recommend replacing the service door.

Rotten door and jamb

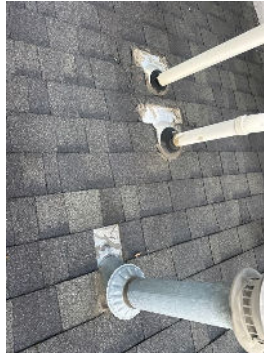
Temporary repairs observed at roof penetrations

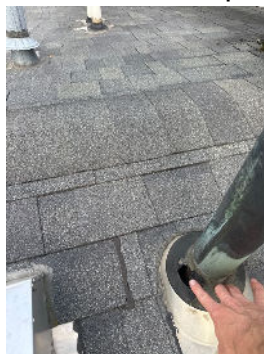
3.1. The vent stack boot(s) were torn prior to the inspection. Recommend installing new vent stack boots to prevent a moisture intrusion.

Multiple torn boots observed

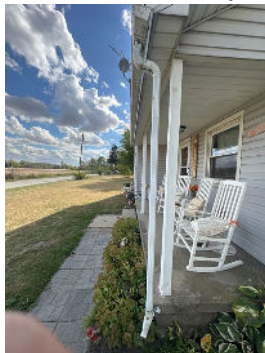
4.4. Gutter(s) are sagging/loose from the home. Recommend securing the gutter(s) to their original location to allow for proper runoff of rainwater.

4.7. The gutter(s) are missing their downspout extension(s). Recommend installing downspout extension(s) to keep water away from the home. NOTE: downspout extensions should be a minimum of 3 ft in length.

Gutters are loose from home and missing proper extensions

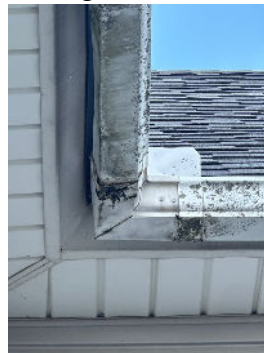
4.5. The seams in the gutters have not been sealed (see picture). Recommend sealing the seams to prevent leaking gutters.

Loose and leaky gutters observed

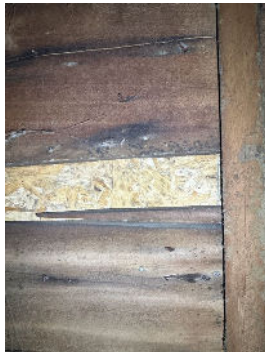
2.1. Mold like substance observed on the underside of the roof deck. Recommend testing the area to ensure the levels of mold then contact a qualified mold mitigation specialists to mitigate if necessary.

Mold like substance throughout framing

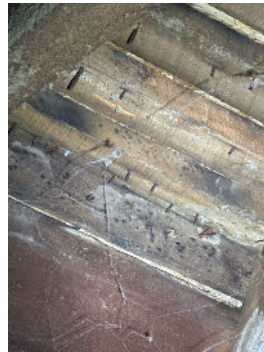
Additional evidence of mold like substance

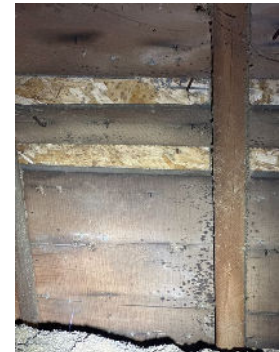
Additional evidence

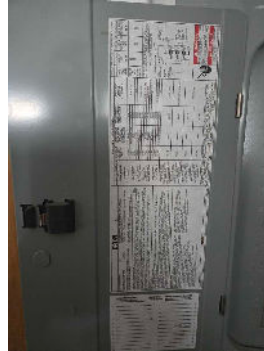
1.1. The individual breakers inside the electrical panel has not been labeled. This ensures breakers can be safely turned on/off while working on separate circuits. Recommend having the electrical panel labeled for improved safety.

Electrical Panel Label

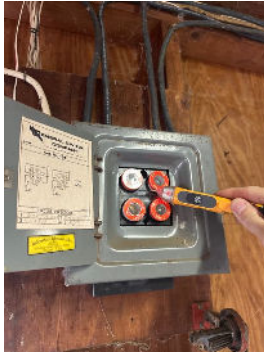
1.2. Fuse panel has been observed as the sub electrical panel. While we understand some of these panels are still operational and can be worked on we recommend upgrading this panel to a newer breaker box style panel for safety concerns.

Live fuse panel in garage

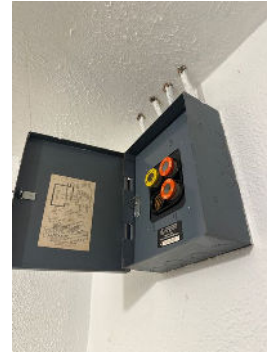
Additional live fuse panel in laundry room closet

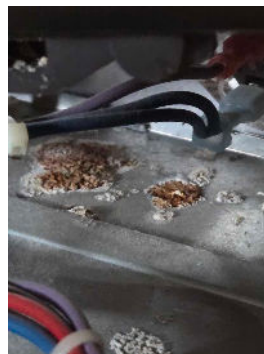
- 1.1. The furnace appears to not have been serviced/cleaned recently. Additionally, the inside of the furnace is also dirty from years of operation. Recommend having the furnace cleaned/serviced by a HVAC contractor.
- 1.2. Corrosion build up observed on the inside of the furnace. On a high efficient furnace they naturally produce a high amount of condensation. If the condensate drain line is not regularly cleaned it can back up into the furnace. However, we recommend a professional HVAC contractor to assess for repairs.
- 1.3. \*\*\*CONDENSATE DRAIN LINE\*\*\*
- 1.4. The condensate drain line is missing its "trap". A trap is necessary to prevent things such as air blockage, siphoning and odor prevention to name a few. Recommend having a trap assembly installed on the condensate drain line.
- 1.5. \*\*\*FURNACE AGE OVERVIEW\*\*\*
- 1.6. 5 - 10 Years Old.

Corrosion observed inside furnace cabinet

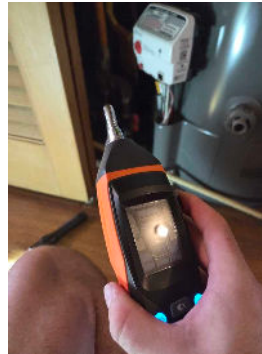
Gas Reading. No leak detected at the time of inspection.

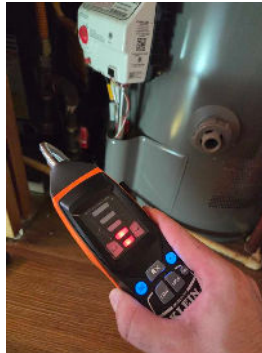
9.2. Gas leak detected (see picture). We recommend consulting with a qualified plumbing contractor to repair the gas line.

Gas Reading. Leak detected at the time of inspection.

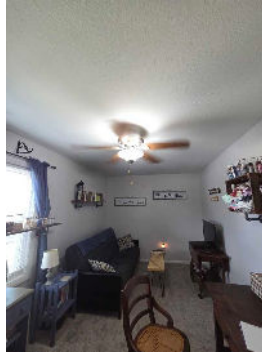
1.2. The ceiling fan(s) make an irregular noise when operated. This is likely caused by an internal issue with the ceiling fan. Recommend replacing the ceiling fan(s).

Fan makes irregular noise.

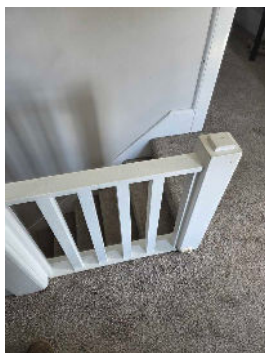
9.4. The guardrail does not meet the minimum vertical requirement of 42" tall. Recommend a professional contractor to install a new guardrail that meets these requirements.

Guard rail does not meet vertical requirements

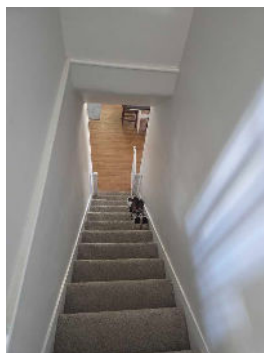
9.2. There is no graspable handrail installed on the staircase going into the upper level. Recommend installing a graspable handrail extending the entire length of the steps. NOTE: Spindles cannot exceed 4" apart.

No graspable handrail going to upper level

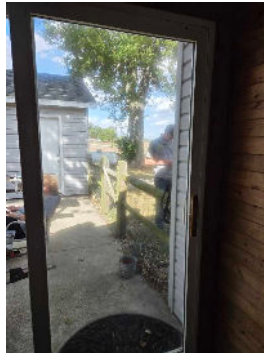
10.1. The patio door has lost its seal, which means the insulating properties of the window has dissipated allowing the window to fog.

Patio door has lost its seal

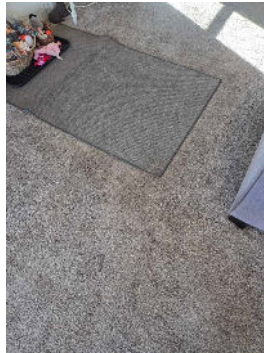
12.2. The flooring has stains, tarnished or worn spots. Sometimes these areas of the flooring cannot be cleaned.

Stained/ worn flooring observed

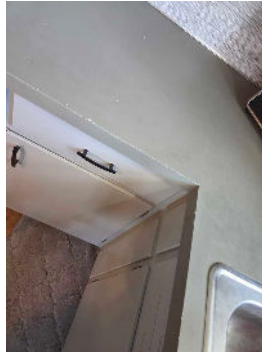
2.1. The counter top(s) are damaged/deteriorated.

Worn countertop finish noted

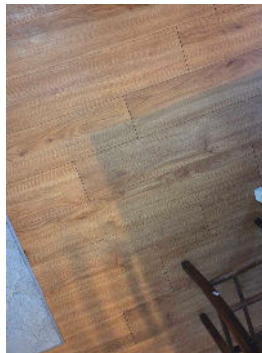
5.2. The flooring has gaps and some pieces are not fully locked in. This is usually caused by improper installation of the flooring.

Gaps in flooring observed

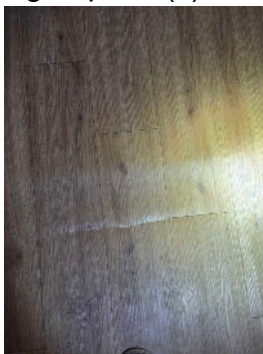
4.2. The finished floor material is damaged. Recommend removing and replacing any damaged piece(s) of finished flooring.

Damaged flooring material observed in doorway

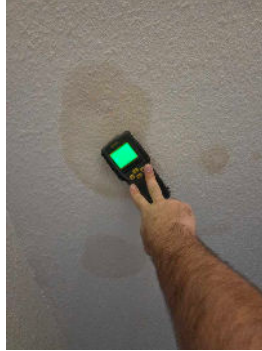
7.1. Evidence of previous moisture damage (was confirmed dry at the time of inspection using a moisture meter). Note: we still recommend verifying the area is dry prior to closing.

Evidence of moisture damage observed. Tested dry during inspection

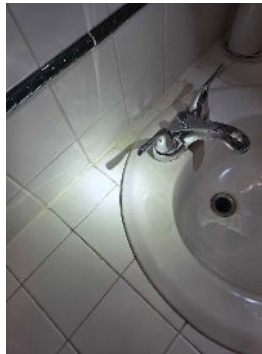
Missing grout between tiles observed

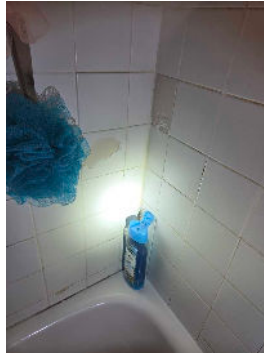
13.1. The grout between the tiles are cracking/missing/loose. Recommend removing any loose/damaged grout and properly grout the areas.

13.2. The tile(s) are cracked/damaged. Recommend removing and replacing any damaged tile(s).

Missing grout and damaged tiles observed throughout shower

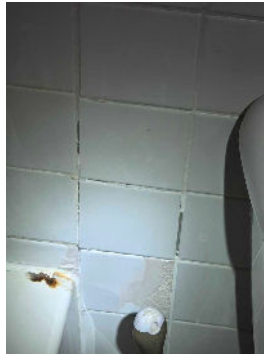
20.1. The grout between the tiles are cracking/missing/loose. Recommend removing any loose/damaged grout and properly grout the areas.

20.2. The tile(s) are cracked/damaged. Recommend removing and replacing any damaged tile(s).

Damaged tiles with missing grout

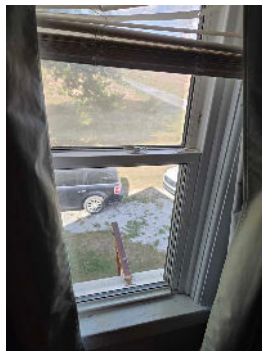
5.2. The window(s) have lost their seal, which means the insulating properties of the window has dissipated allowing the window to fog. Recommend having the seals in the window(s) replaced to improve the insulating properties of the window(s). Note: some window(s) are not able to be repaired and should be replaced by a professional.

Window has lost its seal

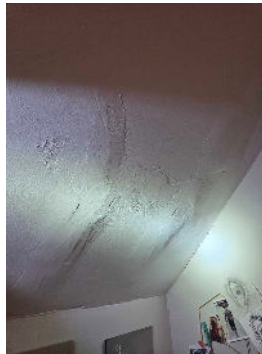
7.1. Improperly repaired section(s) of ceiling observed. Recommend properly repairing the section(s).

Poorly repaired section of ceiling observed

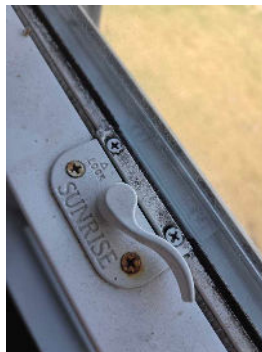
Mold like substance observed on window

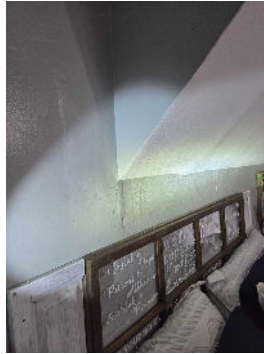
7.2. Improperly repaired section(s) of walls observed. Recommend properly repairing the section(s).

Poorly repaired section of wall observed

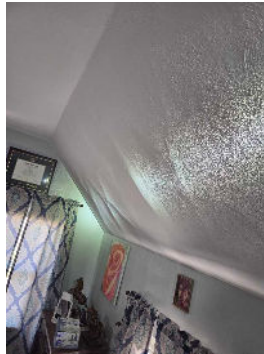
8.2. Improperly repaired section(s) of ceiling observed. Recommend properly repairing the section(s).

Poorly repaired section of ceiling observed

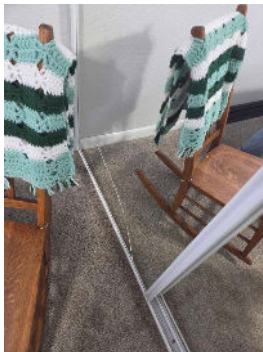
2.2. The glass on the closet door(s) are cracked/damaged. Recommend replacing the glass or door for improved safety.

Cracked mirror on closet door

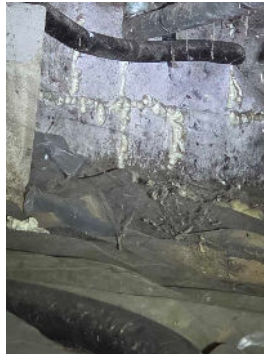
1.3. Diagonal stair stepping settling crack that is wider along the top and slimmer along the bottom of the crack. This means that the foundation may be settling allowing these types of cracks to show up. These cracks can allow water to intrude into the home and may be expanding and contracting in response to the weather. Recommend a crawlspace professional to assess the severity and provide any solutions/repairs needed.

Spray foam repair on north wall

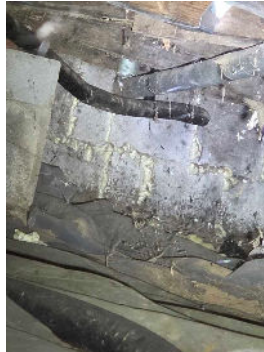
3.1. Missing insulation observed (see picture). Recommend adding additional insulation in this area for increased home efficiency.

Missing insulation on east end

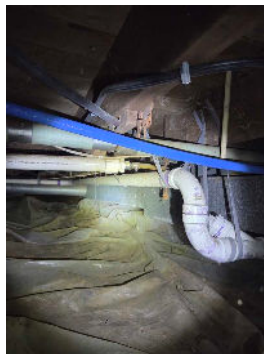
4.2. The drain line(s) are not properly tapered in the crawlspace (see picture). These lines should have a downward slope of 1/4 inch per 10 ft of pipe. Recommend reconfiguring or replacing the drain lines to meet this requirement.

Drain line improperly tapered

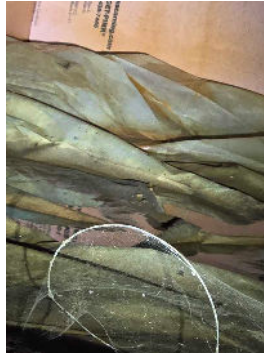
6.1. Standing water observed in the crawlspace (see pictures). Recommend having the water removed from the crawlspace and allow adequate time to dry prior to an inspector returning to the home. For safety reasons the inspector will not be able to fully inspect the crawlspace.

Standing water observed in NW corner

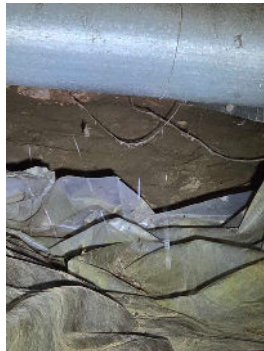
7.1. The vapor barrier that is installed is in poor condition and damaged. Recommend replacing the vapor barrier with a minimal of a 6mm thickness.

Missing proper vapor barrier in SE quadrant

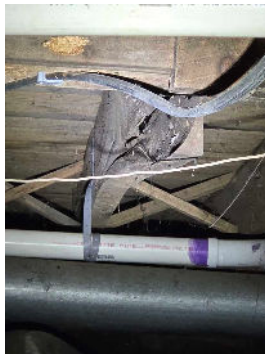
8.6. Cracked floor joist(s) (see picture). Recommend installing a new floor joist directly next to the cracked joist.

Cracked floor joist observed

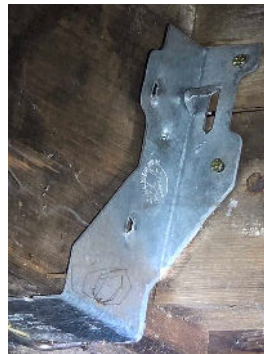
Hangers missing fasteners

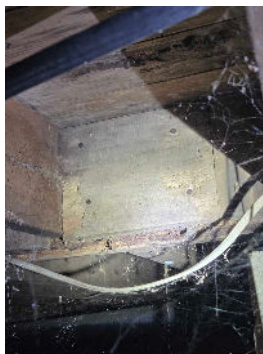
8.8. Evidence of wood destroying organism damage (see pictures). There is visible damage to the structural components of the home (ie; sill plate, rim joist, floor joists etc...). Recommend a professional contractor to assess the extent of the damage and repair all effected areas. Additionally, the infestation does not appear that it is active at the time of the inspection. However, we recommend contacting a professional pest control specialist to asses and treat the home to prevent future infestations.

WDO damage observed to floor joists

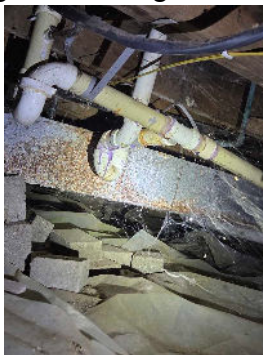
10.1. The ducting is showing signs of rust/corrosion. Recommend repairing/replacing the damaged ducting.

Rusted ducts

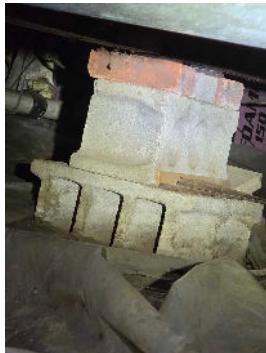
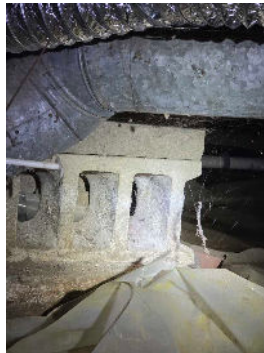
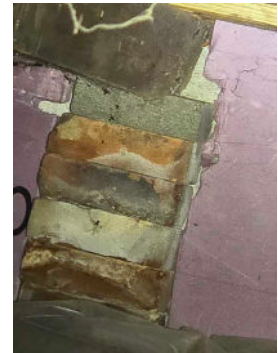
12.1. Improperly installed/built column(s) noted. Recommend removing these column(s) and having them rebuilt to adequately support the load weight of the home.

Improperly built column

Additional evidence

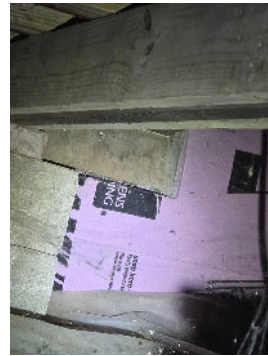
13.1. The crawlspace vent(s) have been blocked with debris. Recommend removing any foreign material from the vent to allow proper air flow for the crawlspace.

Vents have been blocked off

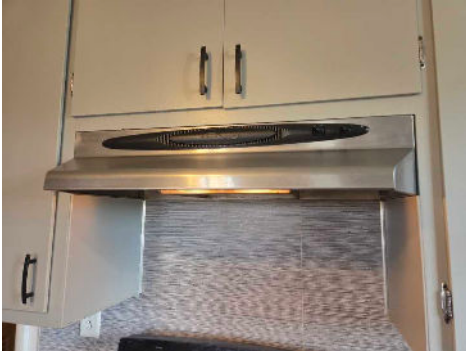
1.1. The range hood did not operate at the time of inspection. Recommend having an appliance repair professional to assess for repairs.

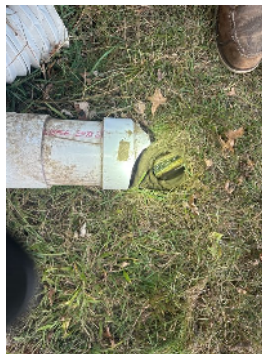
Broken cleanout observed near home leading to tank

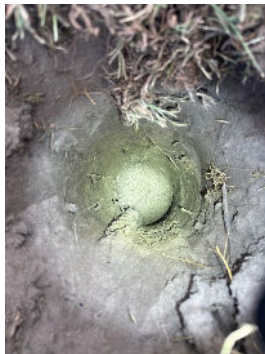
East (front) probe.

8.1. The holes that were dug in the leach field were dry indicating satisfactory condition at the time of inspection.

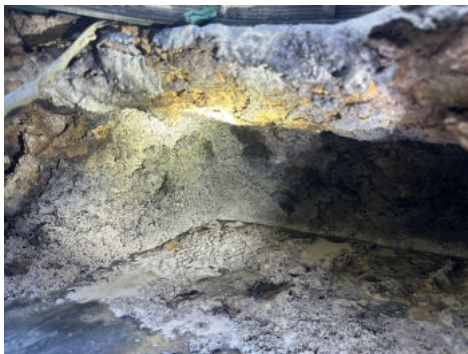
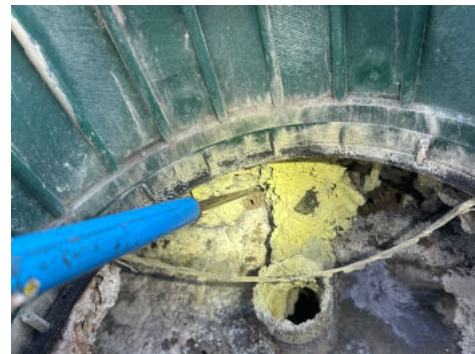
Significant deterioration observed within the concrete on the outlet end of tank. It is highly recommended to engage with a licensed septic contractor to evaluate the tank/system for replacement.

Additional evidence

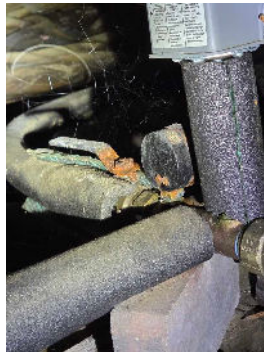
2.1. The observation of corrosion around the well's supply lines, as depicted in the provided picture, indicates a potential issue that requires attention. It is advisable to engage the services of a qualified well contractor to assess the extent of corrosion and replace any fittings or connections showing signs of corrosion. This preventive measure is essential to mitigate the risk of leaks and ensure the integrity of the well system. A qualified professional can identify and address corroded components, helping to maintain the efficiency and reliability of the well's supply lines.

Corrosion observed on supply lines

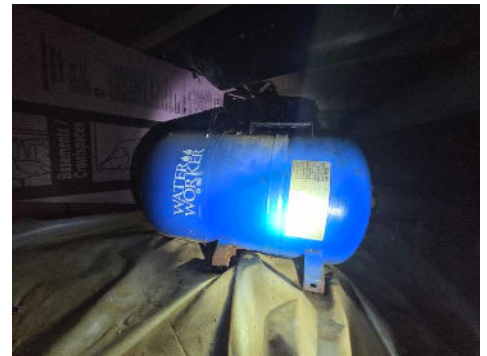
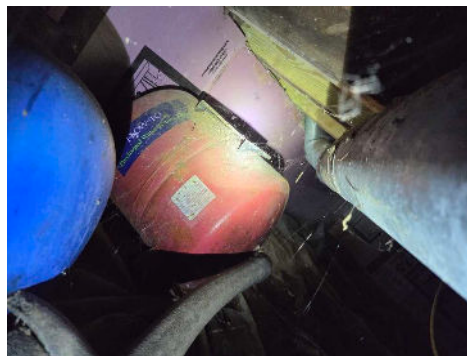
4.1. The rusted condition of the pressure tank enclosure indicates an aging tank. To address this and prevent potential issues, it is recommended to engage a qualified well contractor to replace the pressure tank. Replacing the older tank with a new one will help ensure the continued functionality and reliability of the well system. A qualified professional can assess the situation, recommend an appropriate replacement, and carry out the installation, promoting the efficient operation of the well system.

4.2. The pressure tank is currently lying on the ground, posing a risk of premature wear. To address this issue and prevent potential damage, it is advisable to enlist the services of a qualified well contractor. They can assess the situation and recommend a proper solution, which may include securing or raising the pressure tank off the ground. This proactive measure will help ensure the longevity and proper functioning of the tank within the well system.

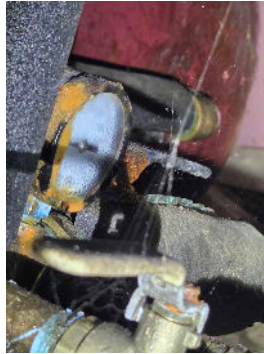
- 6.1. The pressure gauge operated properly at the time of the inspection.
- 6.2. The pressure switch glass/cover is broken.

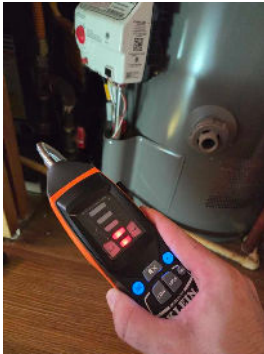
| Attic * | | |
|---|---|---|
| Page 33 Item: 9 | Gas Line & Valve | 9.2. Gas leak detected (see picture). We recommend consulting with a qualified plumbing contractor to repair the gas line. |
| Gas Reading. Leak detected at the time of inspection. | | |

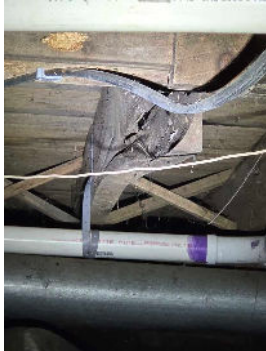
| Page 56 Item: 8 | Framing | <p>8.6. Cracked floor joist(s) (see picture). Recommend installing a new floor joist directly next to the cracked joist.</p> <p>8.7. ***WDO NON -ACTIVE***</p> <p>8.8. Evidence of wood destroying organism damage (see pictures). There is visible damage to the structural components of the home (ie; sill plate, rim joist, floor joists etc...). Recommend a professional contractor to assess the extent of the damage and repair all effected areas. Additionally, the infestation does not appear that it is active at the time of the inspection. However, we recommend contacting a professional pest control specialist to asses and treat the home to prevent future infestations.</p> |
| Cracked floor joist observed | | WDO damage observed to floor joists |

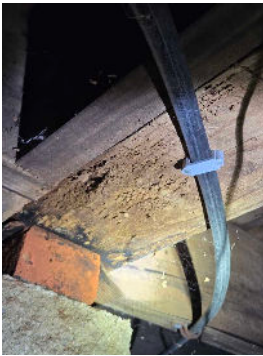
| Page 57 Item: 11 | Beam(s) | <p>11.2. A portion of the beam is rotten/damaged (see picture). A beam is a critical load-bearing structural element that supports the weight of the upper floors and transfers the loads to the foundation below. It is typically a large horizontal beam that runs along the centerline of the basement, supporting the floor joists or other load-bearing elements above. Recommend having a contractor remove and replace the rotten/damaged section of beam.</p> <p>11.3. ***WDO NON -ACTIVE***</p> <p>11.4. Evidence of wood destroying organism damage (see pictures). There is visible damage to the structural components of the home (ie; sill plate, rim joist, floor joists etc...). Recommend a professional contractor to assess the extent of the damage and repair all effected areas. Additionally, the infestation does not appear that the infestation is active at the time of the inspection. However, we recommend contacting a professional pest control specialist to asses and treat the home to prevent future infestations.</p> |

WDO damage observed on beam in center north end

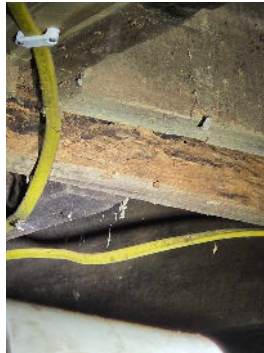
Additional evidence
