# PROPERTY INSPECTION REPORT

CLIENT: Sam Sample

INSPECTOR: Korey Pavlika

DATE OF INSPECTION: 9/24/2025

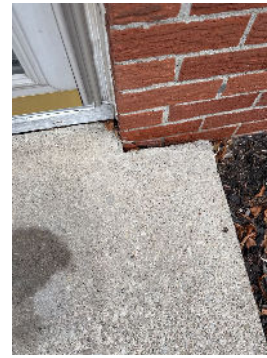
The sidewalk should be sealed to the home

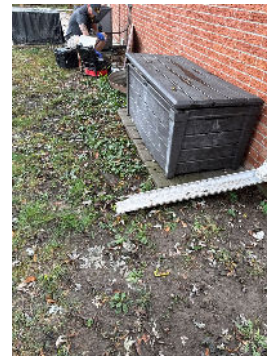
3.1. Lot grading and drainage have a significant impact on the building, simply because of the direct and indirect damage that moisture can have on the foundation. It is very important, therefore, that surface runoff water be adequately diverted away from the home. Lot grading should slope away and fall a minimum of one (1) inch every foot for a distance of six (6) feet around the perimeter of the building.

Negative grade on the northeast corner

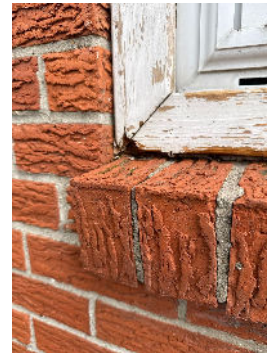
2.2. The window(s) have rotten trim. Recommend removing all rotten trim and installing new material to prevent possible moisture intrusions.

Rotten window trim on the northeast corner window

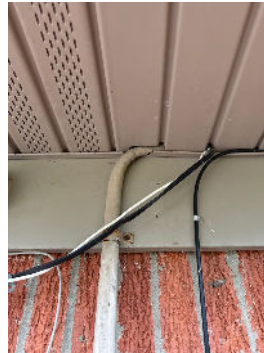
4.1. The soffit is not sealed around the electrical mast. Recommend using a silicone base sealant to seal the electrical mast to the soffit.

The soffit should be sealed around the service entrance wire

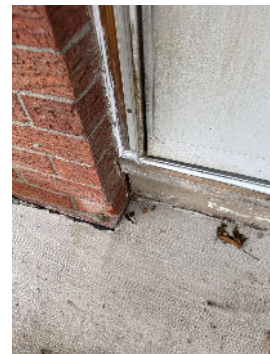
6.1. There is evidence of chipped/peeling paint. Recommend scraping and then painting the areas as needed to protect the substrate.

Small amount of chipped paint under the rear entry door

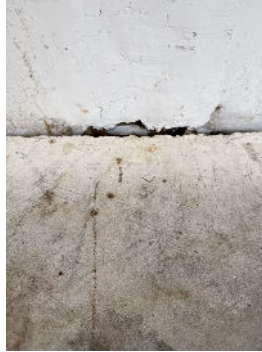
1.1. Cosmetic damage observed to the finish material.

Damaged drywall along the south side of the garage

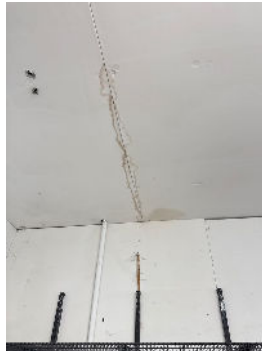
3.1. Evidence of previous moisture damage (was confirmed dry at the time of inspection using a moisture meter). Note: we still recommend verifying the area is dry prior to closing.

Moisture stained area observed

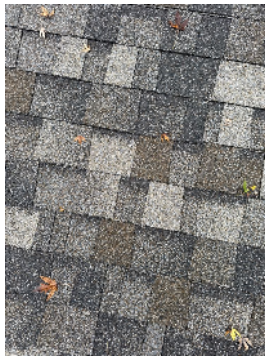
1.2. The shingles have been installed with an oversized exposure (see picture). The minimum exposure for shingles depends on the type of shingle and roofs slope, however most single manufacturers utilize 5 5/8 inches as their recommendation. This can lead to leaks, wind damage, premature shingle deterioration, water infiltration and potential void of manufacturers warranty.

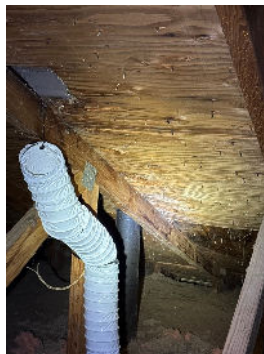
3.1. Evidence of previous moisture damage (was confirmed dry at the time of inspection using a moisture meter). Note: we still recommend verifying the area is dry prior to closing.

Evidence of previous moisture damage observed by exhaust vent. Slight sag observed in decking.

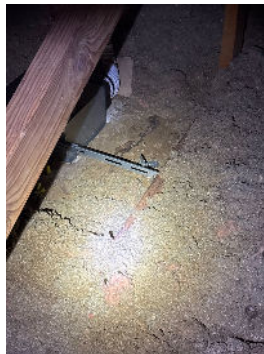
8.1. Missing insulation observed (see picture). Recommend adding additional insulation in this area for increased home efficiency.

Missing insulation around exhaust vent

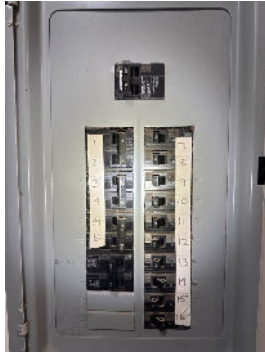
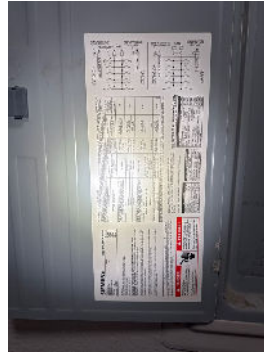
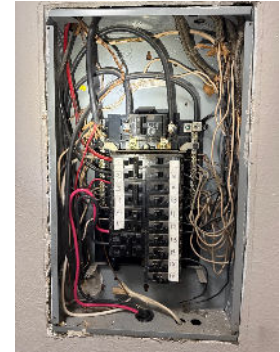
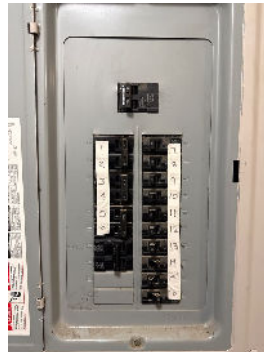
1.1. Some of the individual breakers inside the electrical panel has not been labeled. This ensures breakers can be safely turned on/off while working on separate circuits. Recommend having the electrical panel labeled for improved safety.

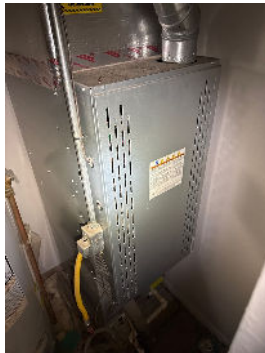
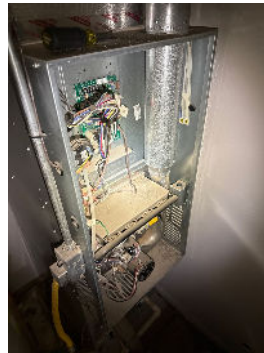
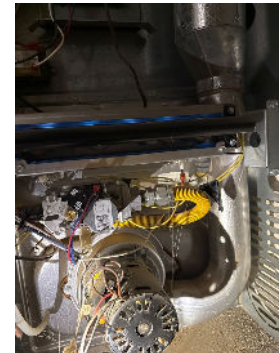
1.1. The furnace appears to not have been serviced/cleaned recently. Additionally, the inside of the furnace is also dirty from years of operation. Recommend having the furnace cleaned/serviced by a HVAC contractor.

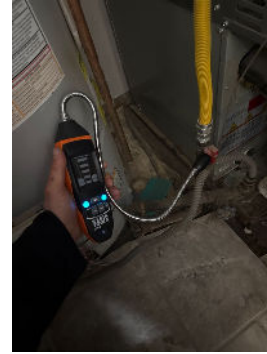
Gas Reading. No leak detected at the time of inspection.

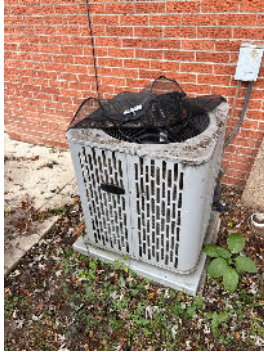
1.1. It appears the AC unit has not been serviced in quite some time. Recommend a professional HVAC contractor to service the AC unit.

Current Condition

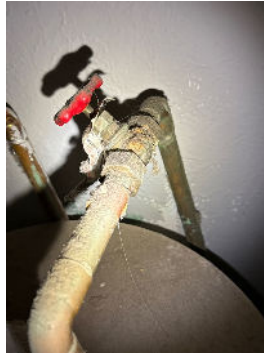
6.1. Corrosion observed on the supply line(s) fittings/valves. This is caused by a physical and chemical reactions between the piping material and water. Copper corrosion leaves a blueish stain while having excessive iron in the water supply leaves a reddish/rust color corrosion. These areas of corrosion should be monitored for repairs/replacements.

Corrosion observed on the supply line fittings

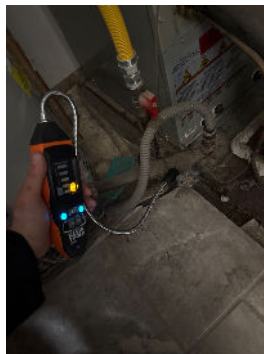
Gas Reading. No leak detected at the time of inspection.

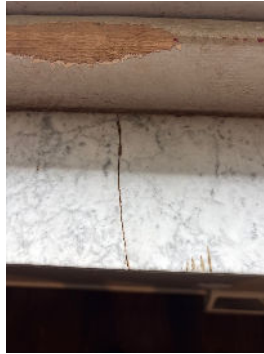
Window sill is cracked at front wall

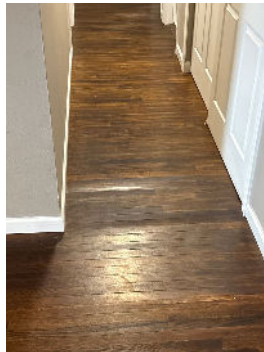
Multiple areas of living room and hallway flooring not level

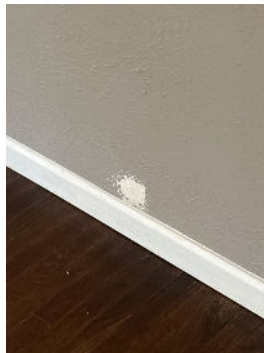
12.1. Improperly repaired section(s) of walls observed. Recommend properly repairing the section(s).

Poor repairs observed

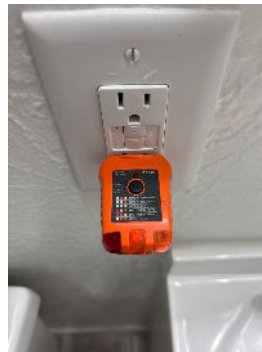
5.1. The GFCI protected outlet(s) were not wired properly, in which did not allow the GFCI to operate when it should. Recommend properly wiring the GFCI so it can operate as intended.

Outlet not properly wired

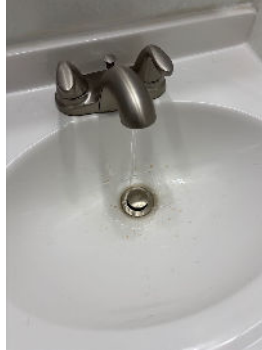
10.1. The sink had low water pressure at the time of inspection. Recommend a professional plumbing contractor to assess the sink supply lines for repairs. Note: sometimes the shut off valves can be turned partially off and should be checked prior to hiring a plumbing contractor.

Low water pressure to sink when tested

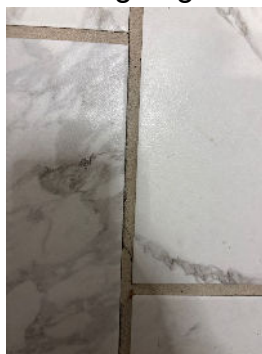
7.2. The grout between the tiles are cracking/missing/loose. Recommend removing any loose/damaged grout and properly grout the areas.

Cracked grout joints observed. Tiles were not level due to poor install.

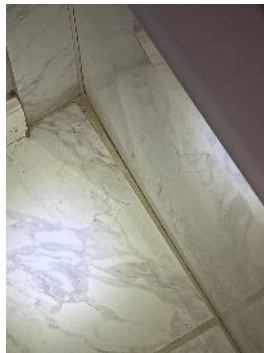
15.1. The tub enclosure is not sealed to the floor. Recommend sealing the tub enclosure to the floor to prevent any moisture intrusion between the gap.

Tub isn't fully sealed to floor

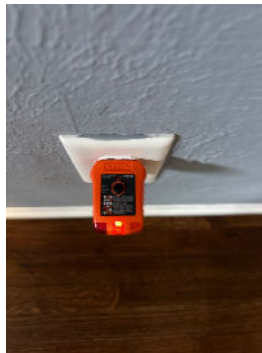
5.2. Open ground (or 2-wire) outlets present. This means that the 3rd (round) part of an appliance plug is not getting ground protection. This may be a concern with items such as computers and electronic devices. Recommend converting the outlet back to a 2 prong outlet or ground the outlet(s) with a GFCI protected outlet/breaker.

Open ground outlets in bedroom

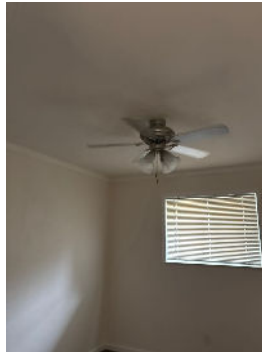
Ceiling fan wasn't controlled by switch. Had to be manually turned on and off.

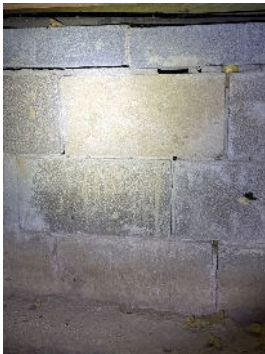
Shifted block on the south wall

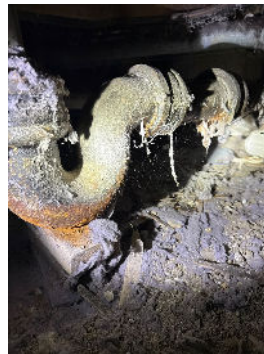
Several cast iron fittings are actively leaking

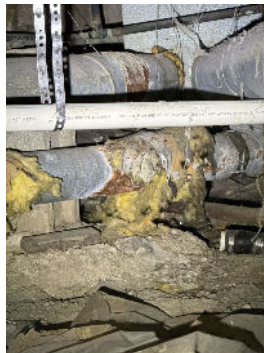
Corroded/rusted ducting observed under the furnace

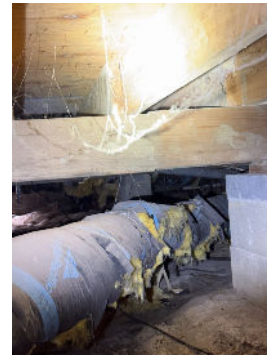
Several sections of beams have not been supported where the wood joins together

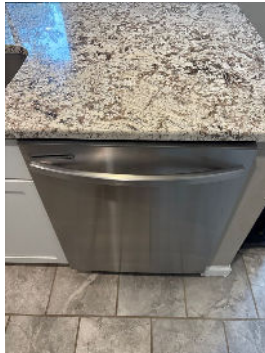
1.1. The dishwasher is not secured within the designated area. Recommend having the unit secured to the cabinet/counter top.

Current Condition.

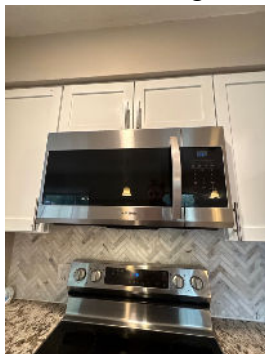
2.1. Operated normally at the time of inspection. We do not guarantee future operation, therefore we recommend confirming proper operation prior to closing during the final walkthrough on the property.

Current Condition.

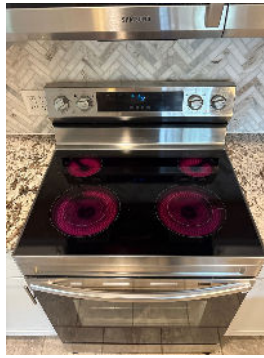
3.1. Operated normally at the time of inspection. We do not guarantee future operation, therefore we recommend confirming proper operation prior to closing during the final walkthrough on the property.

Current Condition.

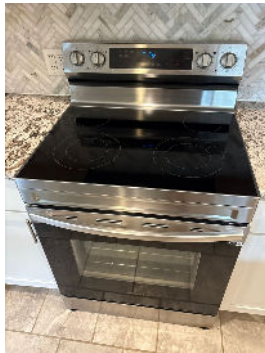
4.1. Operated normally at the time of inspection. We do not guarantee future operation, therefore we recommend confirming proper operation prior to closing during the final walkthrough on the property.

Current Condition.

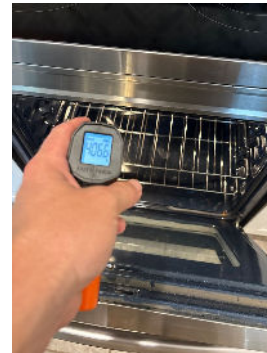
Oven Operating Temperature.

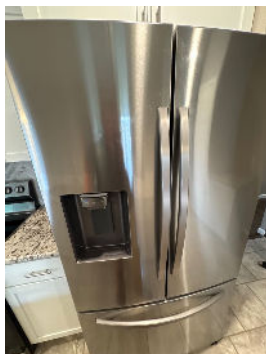
5.1. Operated normally at the time of inspection. We do not guarantee future operation, therefore we recommend confirming proper operation prior to closing during the final walkthrough on the property. Additionally, we do not test the appliances water/ice feature and these features should be confirmed with the seller prior to closing.

Current Condition.

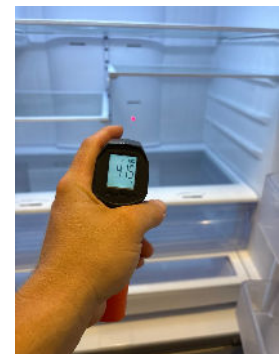
Fridge Operating Temperature.

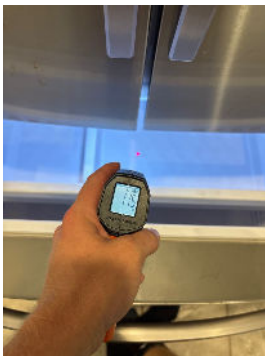
Freezer Operating Temperature.

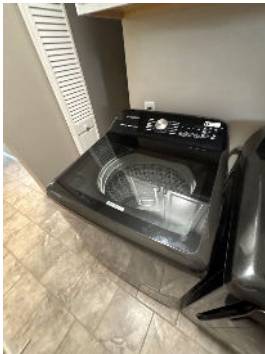
Appliance Brand: Samsung  
Notes/Recommendations:  
6.1. We do not test this appliance for functionality. This is for informational purposes only.

Current Condition.

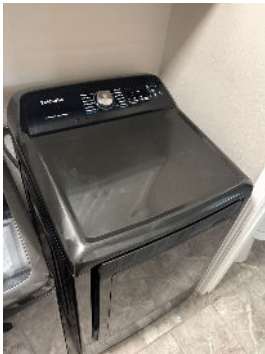
Appliance Brand: Samsung  
Notes/Recommendations:  
7.1. We do not test this appliance for functionality. This is for informational purposes only.

Current Condition.

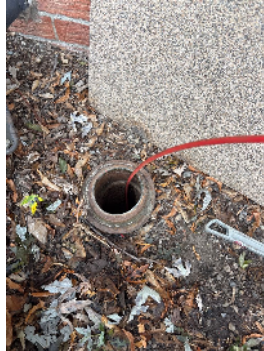
Access Point.

Notes/Recommendations:  
1.1. Exterior Clean Out.

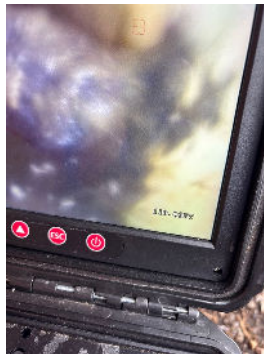
2.1. 115 - 120 Ft.

2.2. The main city drain pipe connection was reached at the time of inspection.
